Benchmarking Evaluation Methodologies for Existing Reinforced Concrete Buildings

Applied Technology Council

March 2022

NIST GCR 22-917-50

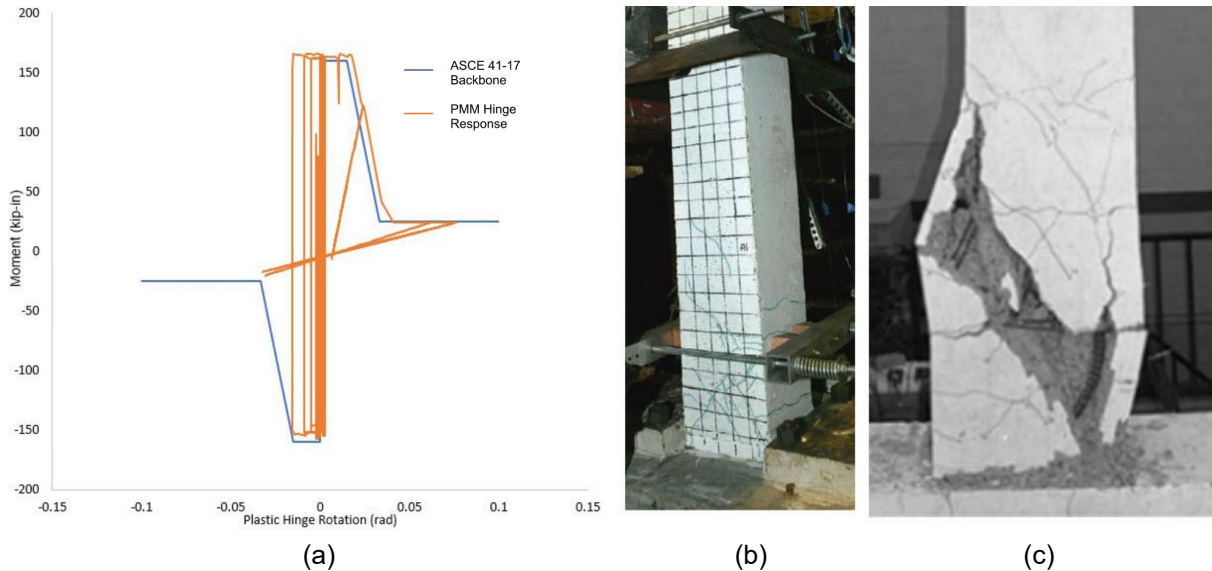
Figure 3-15   NDP Perform3D: Comparison of (a) simulated response, (b) observed damage, and (c) similar lab specimen (specimen at 5.5% drift, from Sezen and Moehle (2006)) for Column A1 at base.

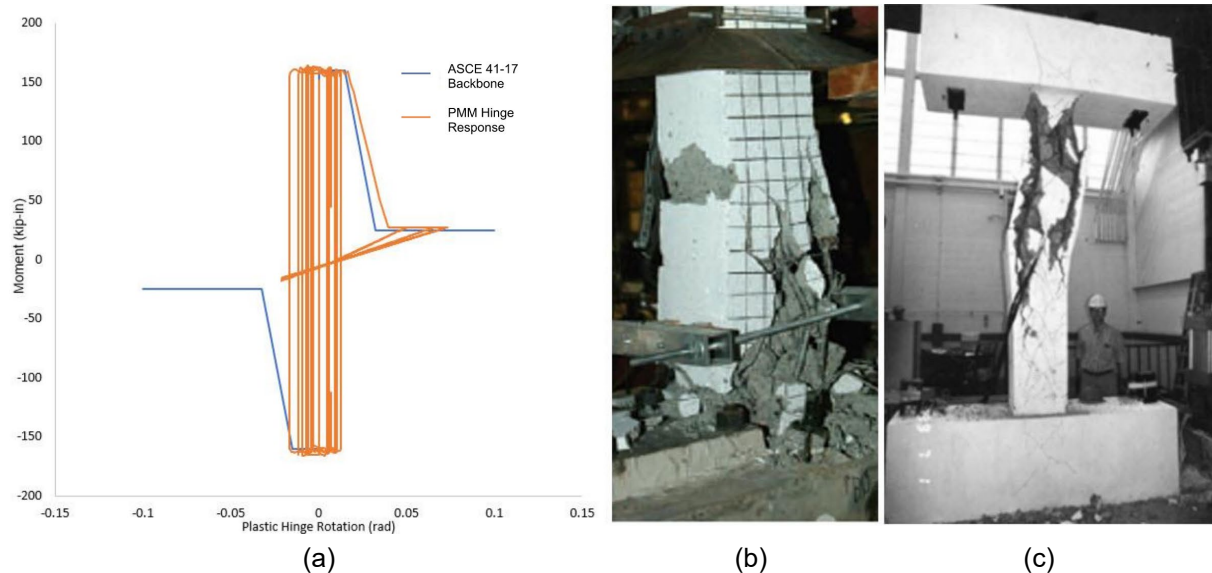
Figure 3-16   NDP Perform3D: Comparison of (a) simulated response, (b) observed damage, and (c) similar lab specimen (specimen at 5.5% drift, from Sezen and Moehle (2006)) for Column B1 at base.

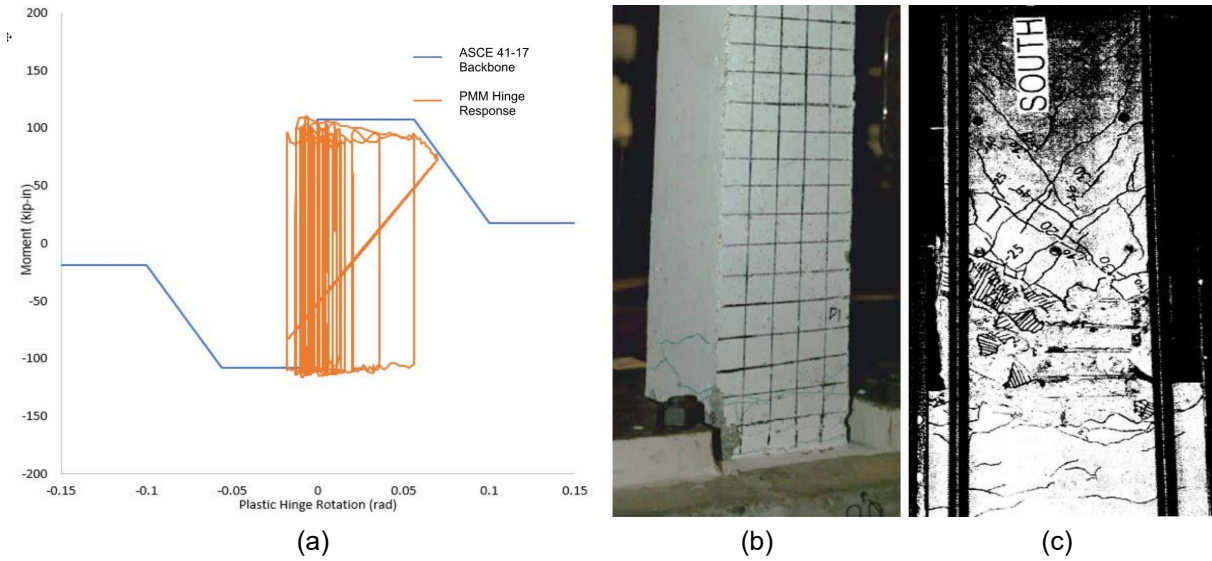
Figure 3-17   NDP Perform3D: Comparison of (a) simulated response, (b) observed damage, and (c) similar lab specimen (specimen at 5% drift, from Pujol (2002)) for Column D1 at base.

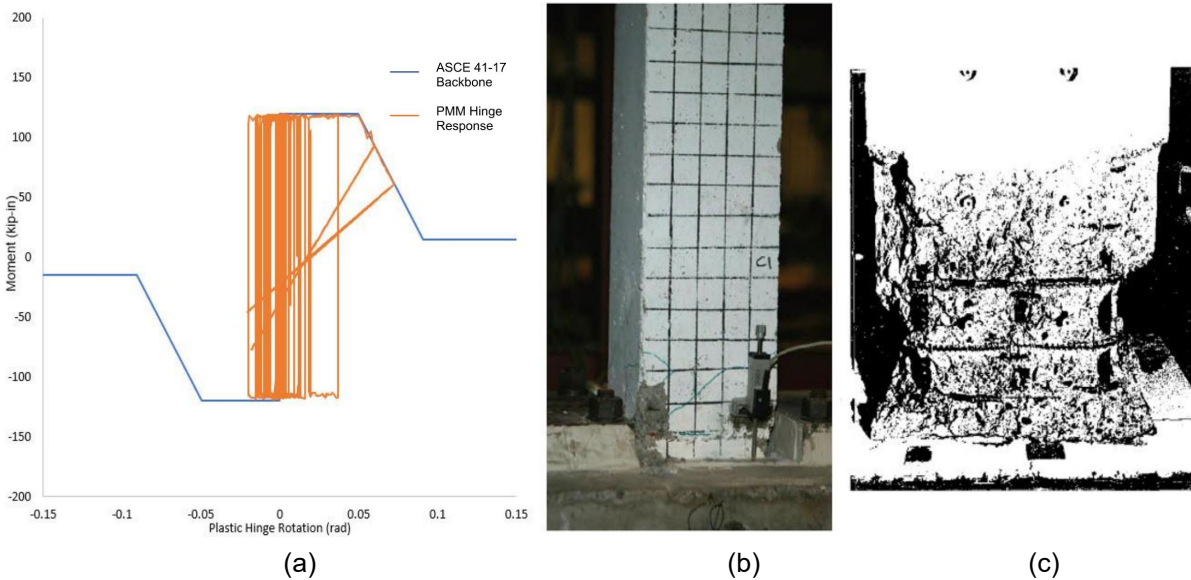
Figure 3-18   NDP Perform3D: Comparison of (a) simulated response, (b) observed damage, and (c) similar lab specimen (specimen at 7.5% drift, from Tanaka (1990)) for Column C1 at base.

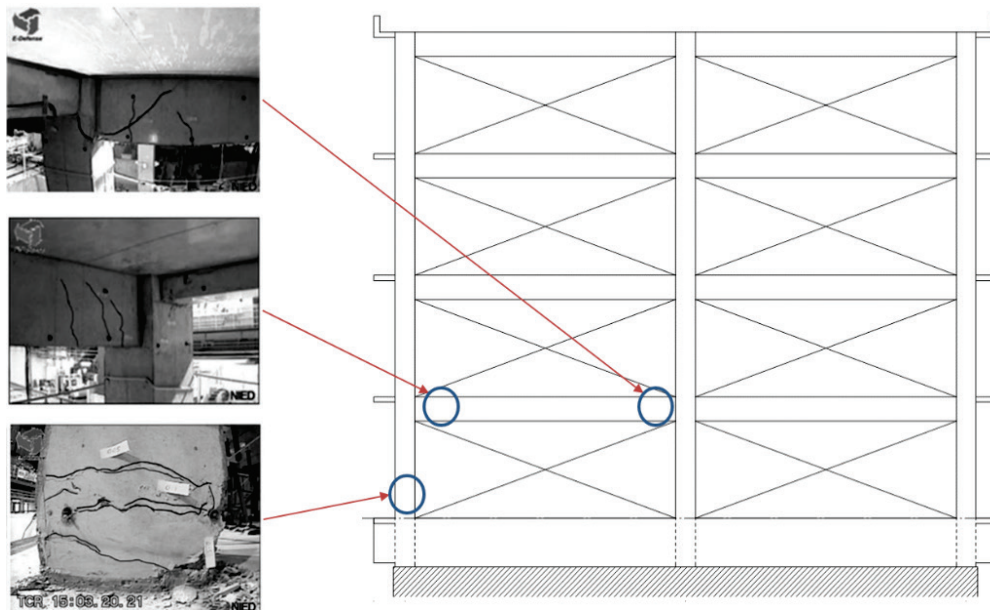
Flexural yielding was recorded in beams and columns up to the third story. Various levels of cracking were observed at the ends of beams and at the base of columns in the first level. Minor concrete spalling also occurred at the base of the columns in the first story as highlighted in Figure 4-10. The beam-column joints suffered shear damage at the second floor, with the interior joints sustaining the most severe damage (Figure 4-10 and Figure 4-11). Damage was anticipated in the joints since they did not satisfy the confinement requirements of ACI 318-14 for Special Moment Frames.

Figure 4-10   Observed damage in moment frame at Gridline 2 (Nagae et al., 2015).

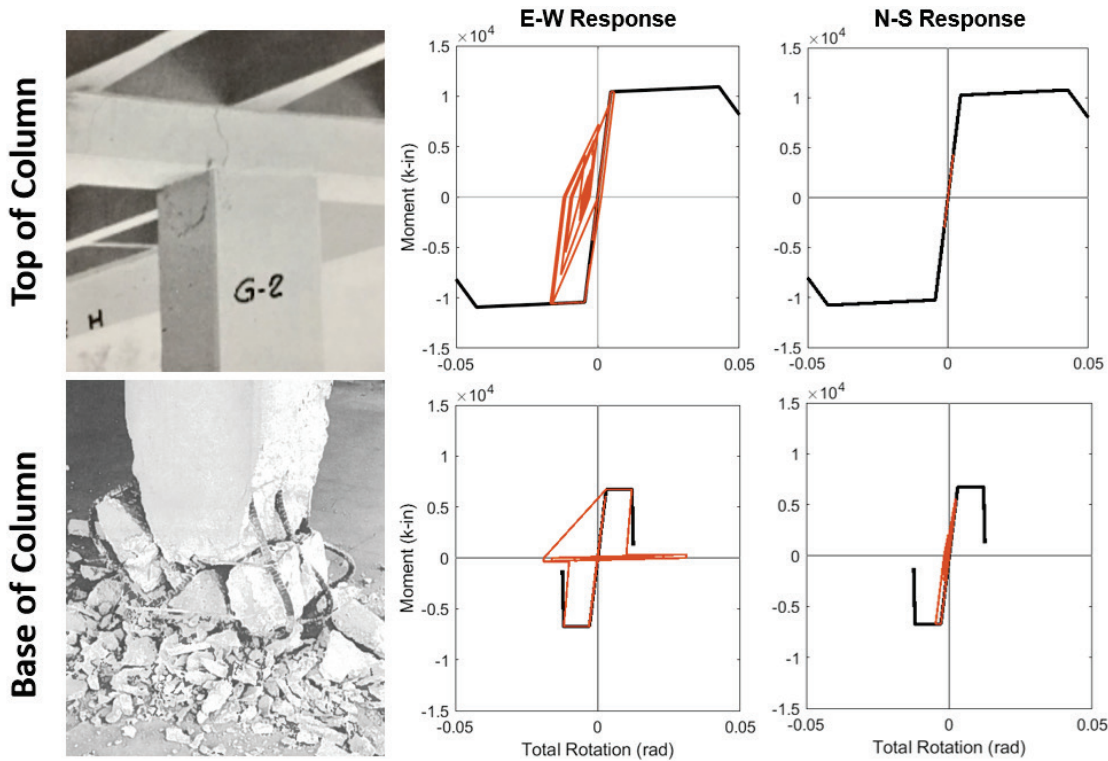
Figure 6-12   Damage photos (ATC, 1984) of column G-2 (see Figure 6-1 for column numbering), with model backbones and hysteretic response in the recorded ground motion. Total rotation of each hinge is defined as the sum of the elastic rotation of half of the column and the plastic rotation of the hinge.

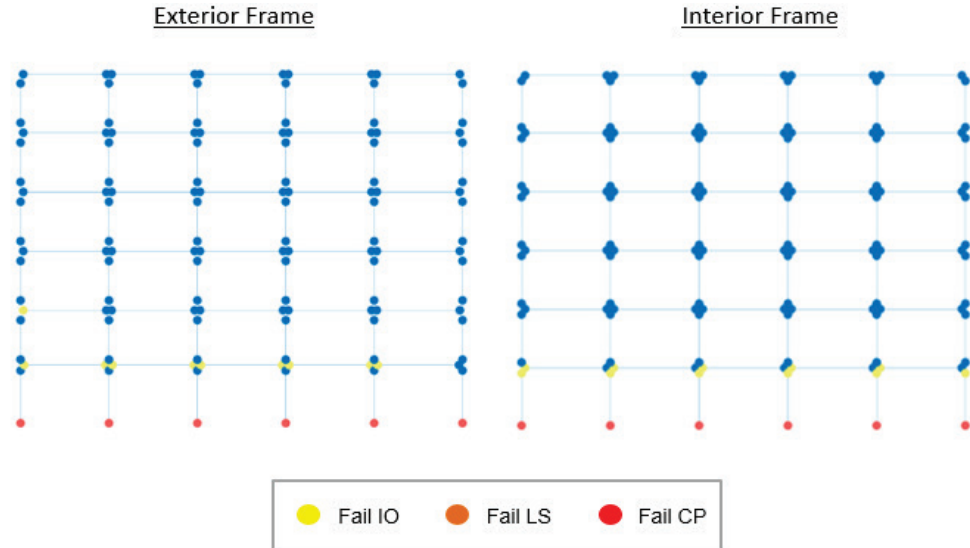
The distribution of damage over the height of the building is illustrated by comparison to ASCE 41-17 acceptance criteria in Figure 6-13. The model predicts

that the columns fail Collapse Prevention (CP) at the base of the first-story columns, and Immediate Occupancy (IO) at the top of some of the first-story columns. Post-earthquake reconnaissance reported little to no damage in upper story columns, and the model response is consistent with these reports. The model predicts that most of the beams did not yield.

Figure 6-13   NDP: Assessment of column and beam response relative to ASCE 41-17 nonlinear acceptance criteria. Immediate Occupancy (IO), Life Safety (LS), and Collapse Prevention (CP).

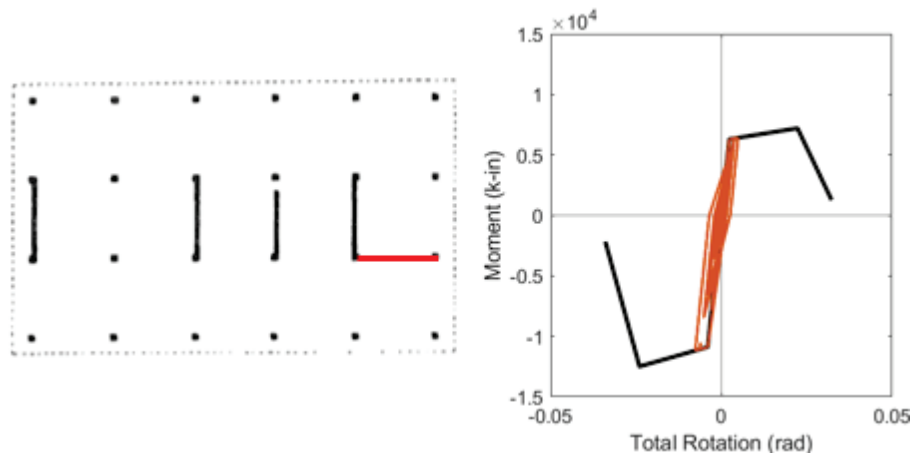
The second-floor beams failed the Immediate Occupancy acceptance criteria, with hysteretic response illustrated in Figure 6-14. Damage surveys found only minor cracking in beams throughout the building. No damage was reported to joints in any of the available damage surveys, and no damage to joints was indicated by the analysis.

Figure 6-14   NDP: Model backbone and hysteretic response of a beam at the second floor. Total rotation of the hinge is defined as the sum of the elastic rotation of half of the column and the plastic rotation of the hinge.

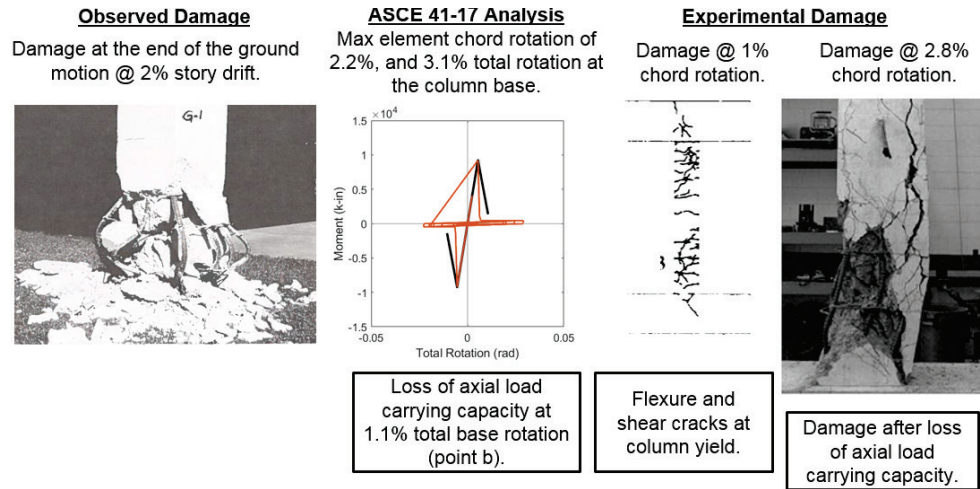
Photos of the observed damage at the base of corner Column G1, the element response from the analysis, and the damage to the experimental column are provided in Figure 6-15. The analysis results indicate that the column failed in shear and exceeded *b* (i.e., lost gravity-load carrying capacity) at 1.1% total rotation. The test column exhibited flexure and shear cracks, and lost axial load carrying capacity at 2.8% rotation, which is similar to the total rotation demand on the column in the simulation (3.1%). Damage pictures look similar, although the columns in the study building had more buckling of longitudinal rebar. The modeled column experienced

more damage at lower drifts than the experimental column, even though the experimental column had a higher axial load, indicating that the *b* values calculated with ASCE 41-17 procedures may be conservative.

Figure 6-15   Comparison of observed and experimental damage for column G1 in the first story.

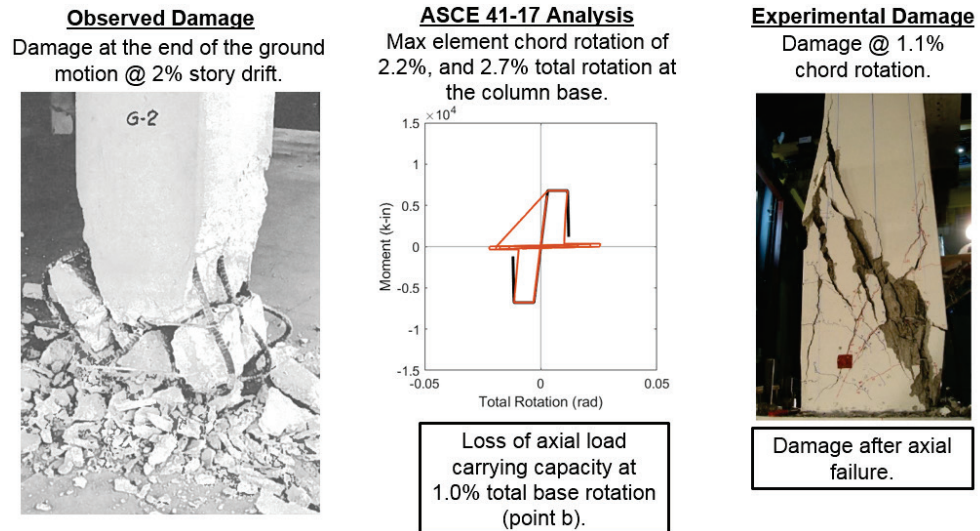
Photos of the observed damage at Column G2, the element response from the analysis, and the damage to the experimental column are provided in Figure 6-16. Figure 6-16 shows that the experimental column lost axial load capacity at around 1.1%, compared to the ASCE 41-17 *b* value of 1.0% (converted to total rotation). These results show reasonable agreement, although the experiment has wider spaced transverse reinforcement.

Figure 6-16   Comparison of observed and experimental damage for column G2 in the first story.

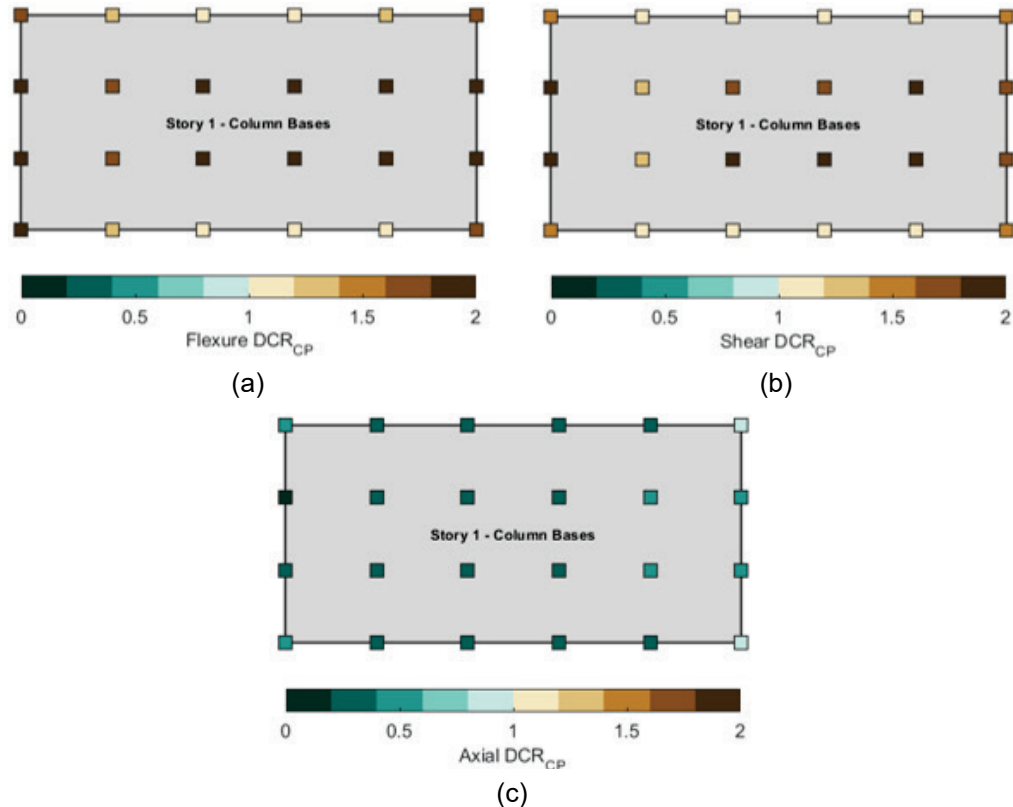
The outcome of the linear model in terms of component acceptance criteria at the first story is shown in Figure 6-22. These results show that all of the columns exceed the linear Collapse Prevention acceptance criteria for both flexure and shear demands at their bases, as indicated by demand-capacity-ratios (DCRs) that have been modified by Collapse Prevention m-factors; DCR/m values greater than 1 indicate failure to meet Collapse Prevention criteria. The tops of the first-story columns, which have a much tighter transverse reinforcement spacing, also fail to meet Collapse Prevention criteria, but to a lesser extent than the column bases. The model

predicts the largest column axial loads to occur on the eastern-most column line in the corner columns, as observed in the damage patterns. The first-story demands in the north-south direction are smaller in the linear analysis response than in the nonlinear analysis, and therefore predicts less column deformation in that direction, and the bi-directional shear behavior may have contributed to their failure in the actual building. Columns were modeled without considering bi-directional shear effects as ASCE 41-17 does not explicitly provide guidelines on modeling such columns.

Figure 6-22   Linear Collapse Prevention Demand-Capacity Ratios modified by m-factors (DCR/m) at base of first-story columns for: (a) flexure; (b) shear; and (c) axial.

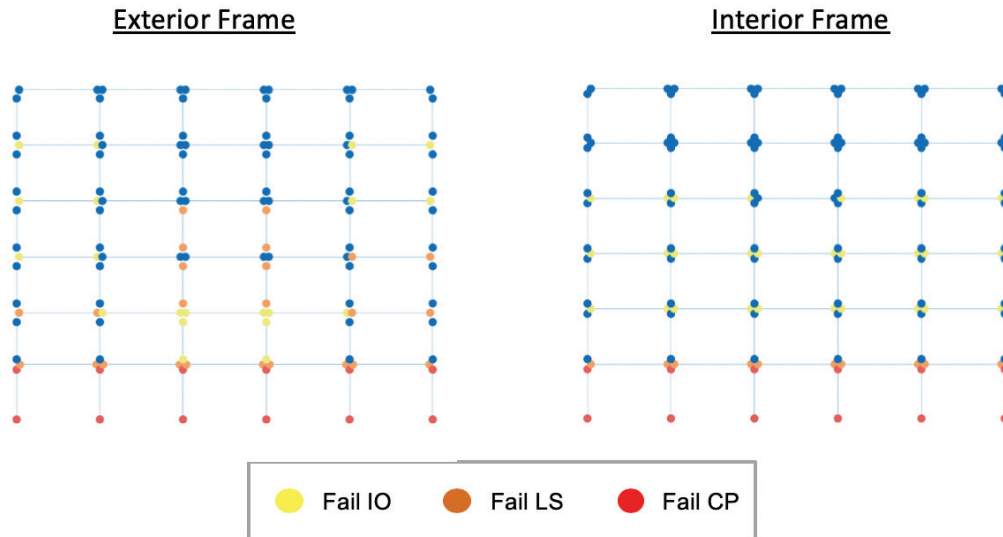
Acceptance criteria for the frame lines in the rest of the building are shown in Figure 6-23. The analysis predicts that some columns and beams at upper stories fail Life Safety acceptance criteria, and many of the interior joints fail to meet Collapse Prevention and Life Safety acceptance criteria, despite the limited observed damage. The analysis also predicts the first-story walls and the upper story wall on the east side will fail to meet the Collapse Prevention criteria. This result is inconsistent with observations of damage, which report only diagonal cracking on the first-story walls and minor cracking on the upper story walls. In the nonlinear assessment, the first-story columns undergo significant strength deterioration, forming a first-story column mechanism which protects the upper stories from extensive drifts and damage. The

linear assessment is not able to represent this type of behavior leading to more significant damage predictions in the upper stories. As expected, for severely damaged buildings, linear methods cannot capture effects of damage concentration that may lead to conservative assessments of damage.

Figure 6-23   Assessment of column and beam response relative to ASCE 41-17 acceptance criteria. Immediate Occupancy (IO), Life Safety (LS), and Collapse Prevention (CP).

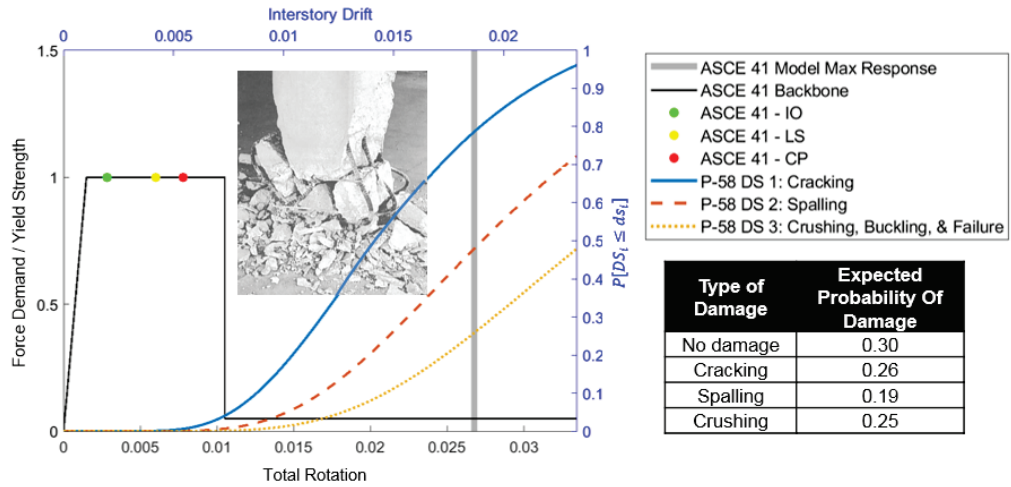
At the base of Column G2, ASCE 41-17 analysis predicts that the column collapses axially, as it is well beyond the b value given by ASCE 41-17. From FEMA P-58, these drift assessments indicate an almost equal likelihood that the column is in any of the three damage states or undamaged. The observed damage to the column seems

to correspond to crushing. However, the ASCE 41 backbone seems to predict more damaged response than the FEMA P-58 fragilities.

Figure 6-24   FEMA P-58 assessment of damage to base of Column G2, comparing ASCE 41-17 backbone (black axes) to FEMA P-58 fragilities (blue axes). Total rotation is defined as the sum of half of the elastic rotation of the element and the plastic rotation of the hinge. The vertical FEMA P-58 axes (blue) shows the probability of exceeding the ith damage state (DS_i).

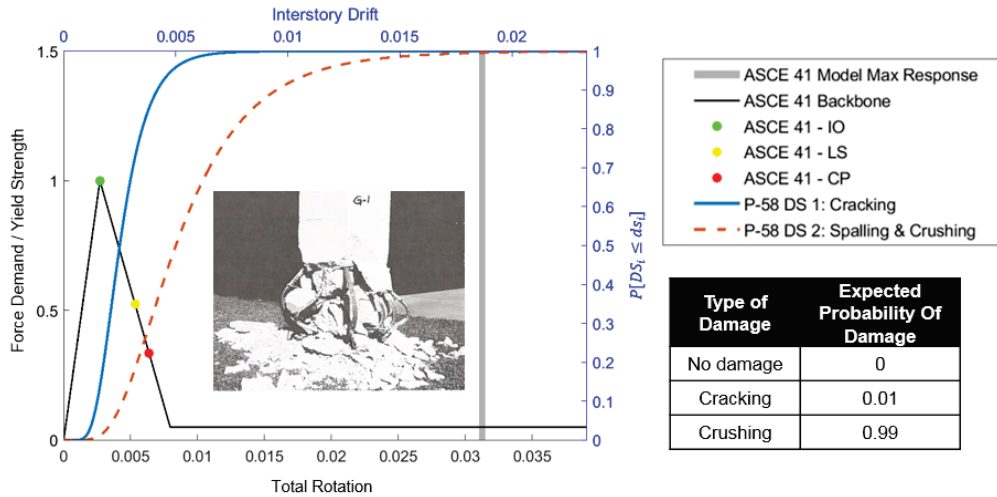
The base of first-story Column G1 is assigned the FEMA P-58 fragility for a non-conforming moment frame with shear-controlled columns and high axial load. This assignment was determined by the comparison of the axial load from the dynamic analysis to the capacity, using axial capacities based on lower-bound material properties. For Column G1, the demand-to-capacity ratio, $P/A_g f'_{cL}$, was greater than 0.6, indicating the column had high axial loads. Results are provided in Figure 6-25, showing good agreement between the ASCE 41 model, the observed damage, and FEMA P-58 assessment of crushing. Because of the assignment of the high axial load fragility to the corner columns on the east side of the building, the FEMA P-58 assessment consistently predicts the worst damage to those columns.

Figure 6-25   FEMA P-58 assessment at base of Column G1, comparing ASCE 41 backbone (black axes) to FEMA P-58 fragilities (blue axes). Total rotation is defined as the sum of the elastic rotation of half of the element and the plastic rotation of the hinge. The vertical FEMA P-58 axes (blue) shows the probability of exceeding the i^{th} damage state (DS_i).

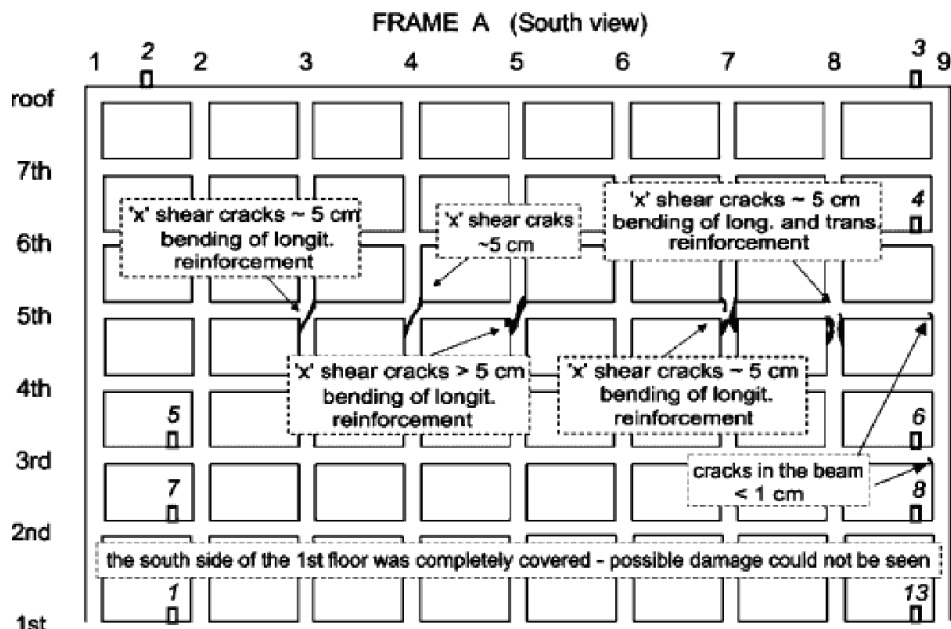
Figure 7-10   Structural damage to south perimeter frame after 1994 Northridge Earthquake (Trifunac et al., 1999).

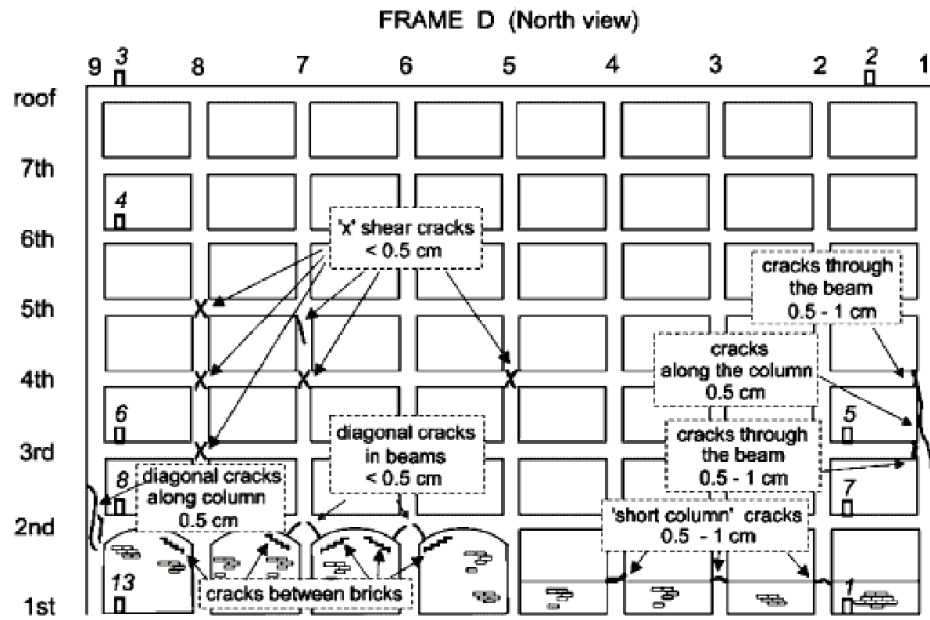
FRAME D (North view)

The 1994 Northridge Earthquake caused severe structural damage concentrated in the fourth and fifth levels of the east-west perimeter frames, where several columns sustained shear failure (Figures 7-10 through 7-13). Trifunac et al. (1999) and Trifunac and Hao (2001) present the results of damage surveys conducted on

February 4, 1994 and April 19, 1994 following the earthquake. They report structural damage in the form of shear failure of columns and beam-column joints in the exterior frames. Reported damage includes spalling of the concrete cover, buckling of the longitudinal reinforcement, and through cracks that were several inches wide in the columns. Damage to the south exterior frame occurred at six locations on the fifth floor (column lines A-3, 4, 5, 7, 8, and 9) and one at the third floor (column line A-9). Damage to the north frame occurred in the full-height infill masonry walls at the ground floor and at the base of the captive columns at the ground floor in column lines D-2, D-3, and D-4. Damage was also reported at 12 different locations at beam-column joints at the second through fifth floors.

Figure 7-11   Structural damage to north perimeter frame after 1994 Northridge Earthquake (Trifunac et al., 1999).

The observed damage pattern in the building showed severe shear distress in columns of exterior frames (Figures 7-11, 7-12 and 7-17). Damage reports from the 1994 Northridge Earthquake (Trifunac et al., 1999; Trifunac and Hao, 2001) do not make any reference to damage to interior columns or slab-column connections, and they describe limited damage to beams.

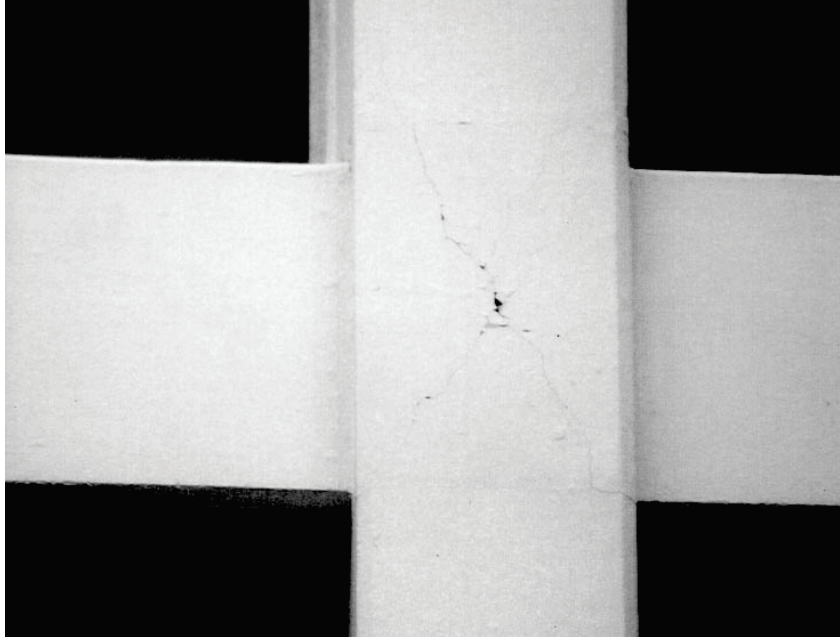
Beam-column joints were modeled using linear elastic elements. The presence of reinforcement in the joints is not legible in the copy of the plans available, so it was not possible to determine with certainty if there was any reinforcement in the joints. A typical column detail in the report by Blume and Associates (1973) shows a reinforcing bar at the center of the joint, which would be sufficient to classify the joint as conforming according to the provisions in ASCE 41. Interior joint shear demands in perimeter frames were calculated for representative joints in all stories and found to range between approximately $7\sqrt{f'_{cE}}$ and $15\sqrt{f'_{cE}}$, which exceeds the capacity of non-compliant joints ($12\sqrt{f'_{cE}}$) but is below the capacity of compliant joints ($20\sqrt{f'_{cE}}$). Although damage surveys show that there were shear cracks in the joints (Figure 7-16), the width of the observed shear cracks in the joints was small, and distress in the columns was severe (Figure 7-17). Columns had observed crack widths on the order of inches (Trifunac et al., 1999). Based on the information available, joints were modeled as compliant elements with a capacity of $20\sqrt{f'_{cE}}$ using elastic elements to include joint flexibility. This assumption was made to reduce computational cost, which was very significant for the model, particularly for the fragility analysis presented in Section 7.4. It was found to provide a more accurate building response for the 1994 Northridge Earthquake than the models shown in ASCE 41-17 Figure 10-2c, 10-2d, and 10-2e (Suwal, 2018).

Figure 7-16   Shear distress in beam-column joint (Trifunac et al., 1999).

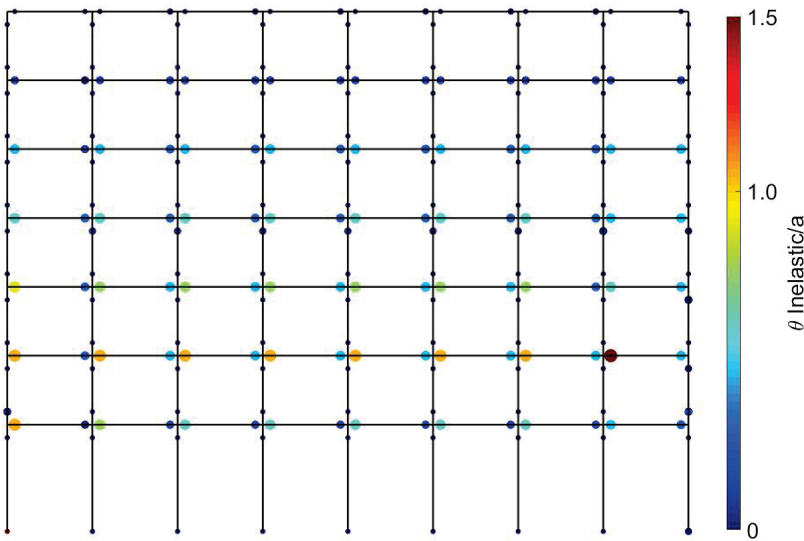
Inelastic rotations presented in Figures 7-33 to 7-36 were extracted from rotational springs. Circle diameters at hinge locations are proportional to the ratio of $\theta_{inelastic}$ to modeling parameter *a*. Circle color is also an indicative of the ratio of $\theta_{inelastic}$ to modeling parameter *a*, with red circles indicating locations where $\theta_{inelastic}$ exceeded modeling parameter *a*. Ratios of calculated inelastic rotations to modeling parameter *a* presented in Figures 7-33 through 7-36 are consistent with the calculated damage patterns in Figures 7-31 and 32, which showed that computed column deformations were small, with most of the column elements not exceeding yield. Calculated inelastic rotations exceeded parameter *a* for a few beams in the lower stories of the exterior north-south frame (Figure 7-33) and the interior east-west frame (Figure 7-36), where no severe damage was reported.

Figure 7-35   NDP: Ratio of maximum beam and column rotation to ASCE 41 parameter *a* for the exterior frame oriented in the east-west direction.

Calculated rotations in exterior beam elements, as large as ASCE 41-17 rotations associated with loss of lateral load capacity, were not consistent with documented damage in the exterior frames. This shows that there were differences in the manner in which inelastic deformations were distributed between beams and columns between the nonlinear model and the building system. The difference is also caused by the fact that modeling parameters and acceptance criteria for beams and slab-column connections are the same adopted in FEMA 356, and correspond to safe lower bound values based on engineering judgement. In the case of columns, modeling parameters and acceptance criteria have been modified two times since the publication of FEMA 356, and current values were calibrated to be representative of the mean response of column subassemblies tested in the laboratory.

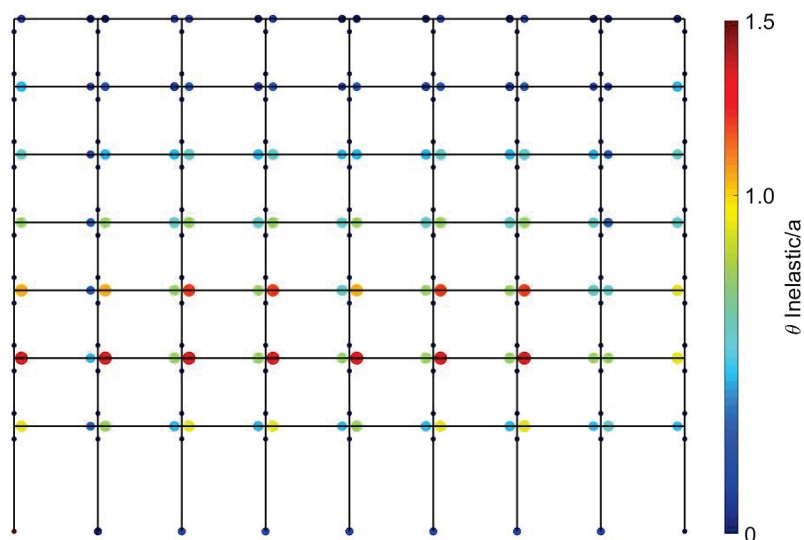
Figure 7-36   NDP: Ratio of maximum beam and column rotation to ASCE 41 parameter *a* for the interior frame oriented in the east-west direction.

In the case of slab-column connections of the east-west frame, calculated inelastic rotations were on the order of 50% higher than ASCE 41 parameter *a* (Figure 7-36), which is indicative of severe distress. Although there is no documented damage at interior slab-column connections, this type of damage is difficult to inspect because connections are covered by floor finishes and ceilings. Also, as in the case of beams, modeling parameters and acceptance criteria for slab-column connections have not been updated since FEMA 356.

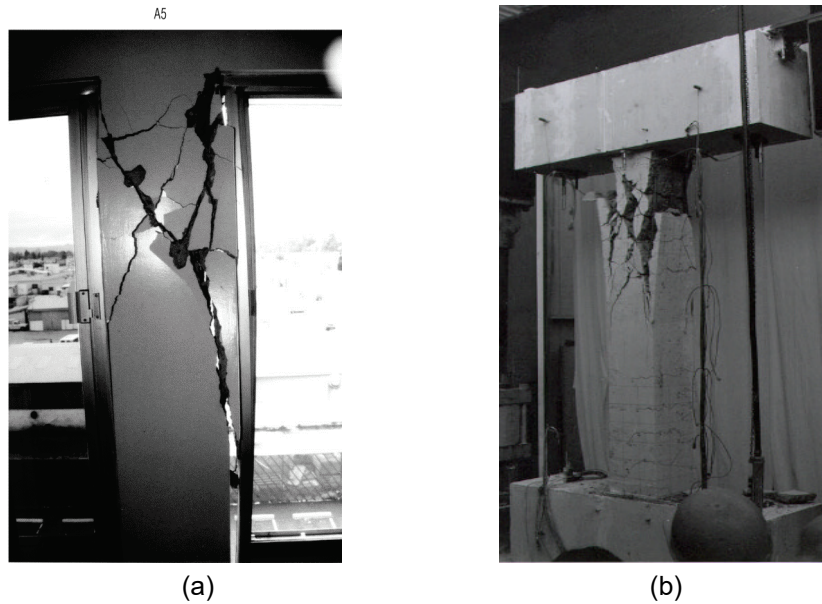
A comparison between Column A5 and a similarly configured column (Specimen 3CLH18) tested in the laboratory by Lynn (1999) is presented in Figure 7-37. Properties for the two columns are presented in Table 7-3, and the calculated response of the OpenSees model is presented in Figure 7-38.

Figure 7-37   Columns (a) A5 at the fifth floor of the south frame (Trifunac et al., 1999), and (b) Specimen 3CLH18 tested by Lynn (1999).

Specimen 3CLH18 was a square 18 in. by 18 in. column with No. 3 hoops spaced at a distance equal to the column dimension. Column A5 had a rectangular section of 14 in. by 20 in. with 4 legs of No. 2 bars spaced at 12 in. Both Column A5 and Specimen 3CLH18 showed a damage pattern consistent with shear failure. Specimen 3CLH18 was shear critical due to the larger longitudinal reinforcement ratio, while Column A5 with a much lower longitudinal reinforcement ratio was flexure-shear critical with a ratio of shear corresponding to yielding of the longitudinal reinforcement to calculated shear strength of approximately 0.85 and a capping rotation of approximately 2%.

Figure 7-37 shows that the two columns, subjected to the similar drift ratios, experienced similar levels of damage. The main difference between Specimen 3CLH18 and Column A5 is that the former had rigid beams so the lateral deformation at the level of the top girder was equal to the lateral deformation of the column.

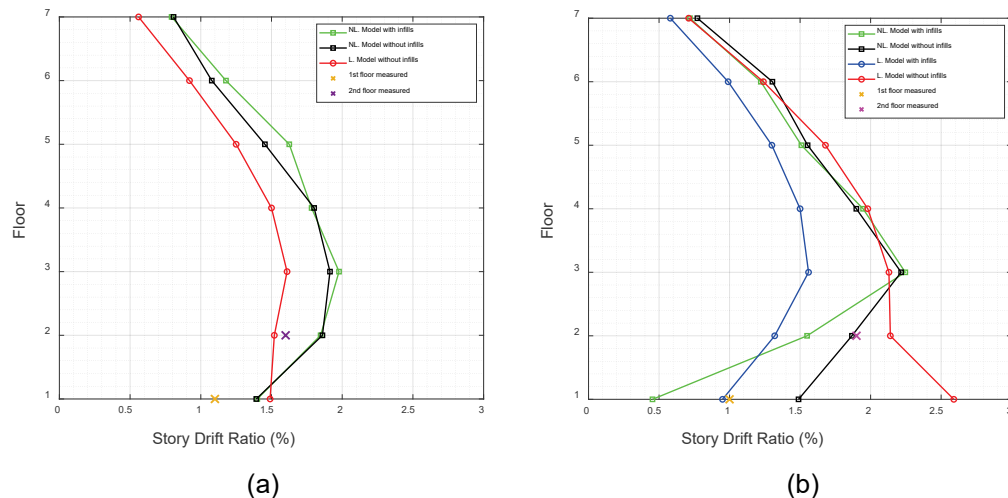
Figure 7-40   LDP: Seismic drift at center of mass (a) north-south direction, and (b) east-west direction.

The largest drift ratio of 2.6% occurs in the model without infill in the longitudinal (east-west) direction at the first story; however, the first story drift ratio is less than 1% when the infill panels are included. Calculated drift ratios in the third and fourth stories were approximately 1.5% in both directions when infill panels are included and 2% for the east-west direction without infill. In both the north-south and east-west directions of linear models with infills, drift ratios at the third and fourth floors are significantly lower than those calculated with the nonlinear dynamic analysis procedure. The difference between calculated displacements with the linear and nonlinear analysis procedures at the roof level is on the order of 40%. Drift ratios at the third and fourth floors in the east-west direction of the linear model without infills were similar to those calculated with the nonlinear dynamic procedure, in both models with and without infills.

The observed damage was most severe in the fourth story. This is somewhat consistent with the calculated drift profiles that show that the peak drifts occur in the third and fourth stories in the north-south direction and the east-west direction (when infill is considered). The model without infills significantly overestimated first story drift despite being modeled with a fixed base.

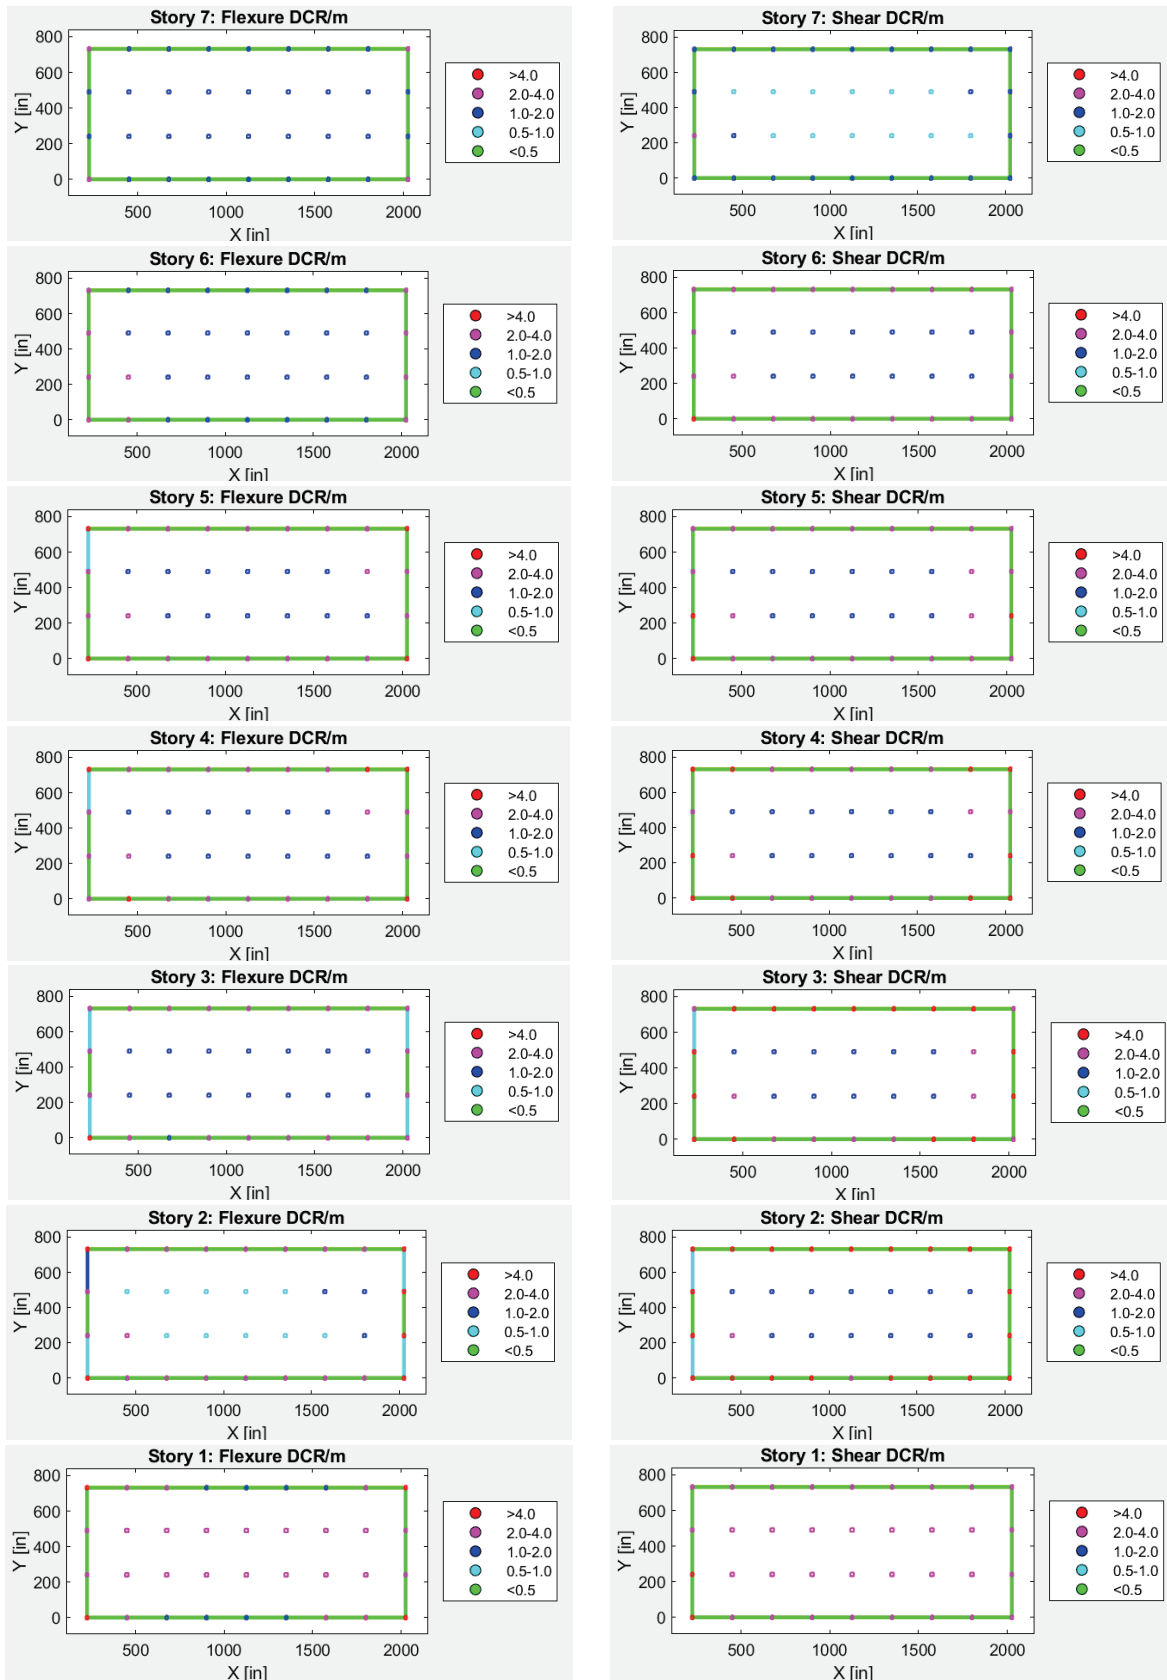
Figure 7-42   Collapse prevention demand capacity ratio for each story.

Results show that all first story columns exceed the CP criteria for shear and flexural demands, and that DCR/*m* values were larger for shear than flexure. Most DCR/*m* values for beams were below 0.5 for shear and flexure. A few beams in the north-south direction had DCR/*m* values in flexure between 0.5 and 1.0, and a beam in the second floor was the only element that exceeded DCR/*m* of 1.0 (Figure 7-42).

The results from the non-infill model show the first story to be the critical story for the gravity columns; however, the perimeter seismic system is most heavily taxed in the third (DCRs for shear higher than 4) and fourth stories (DCRs for shear higher than 2), which is consist with the location of the highest observed damage in the exterior E-W frames.

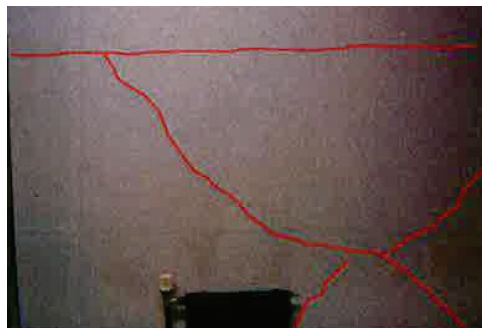
(b) Cracking (≤ 0.2 mm) and minor spalling near middle of east wall

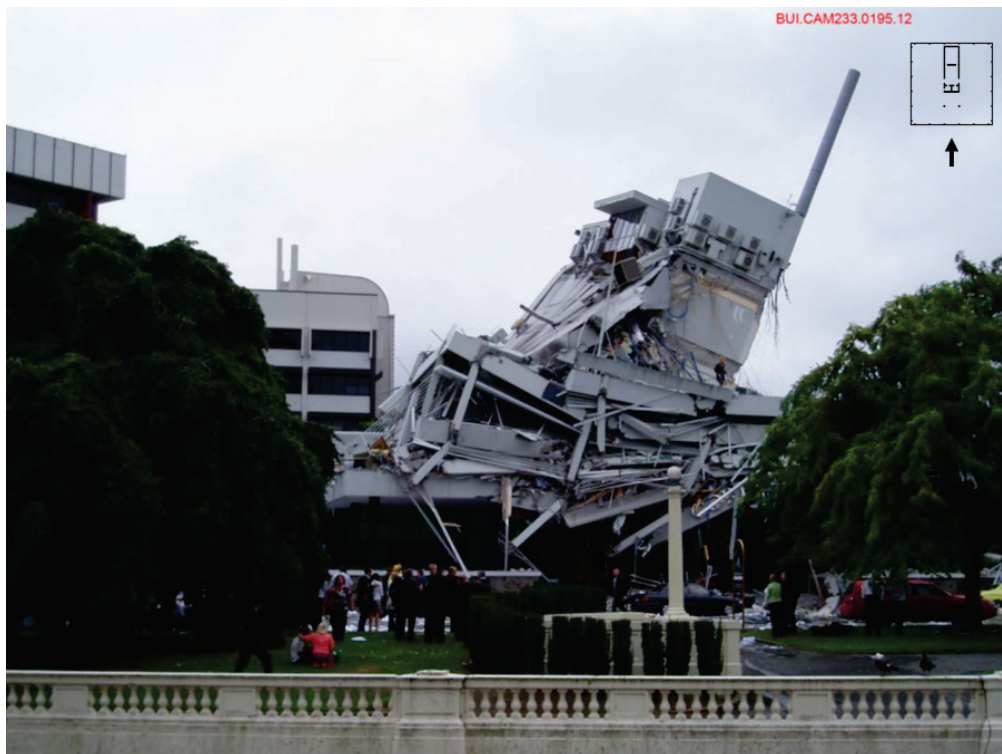
Figure 8-9   Photo showing collapsed building viewed from south (across the Avon River; adapted from Jury and Sharpe [2011]).

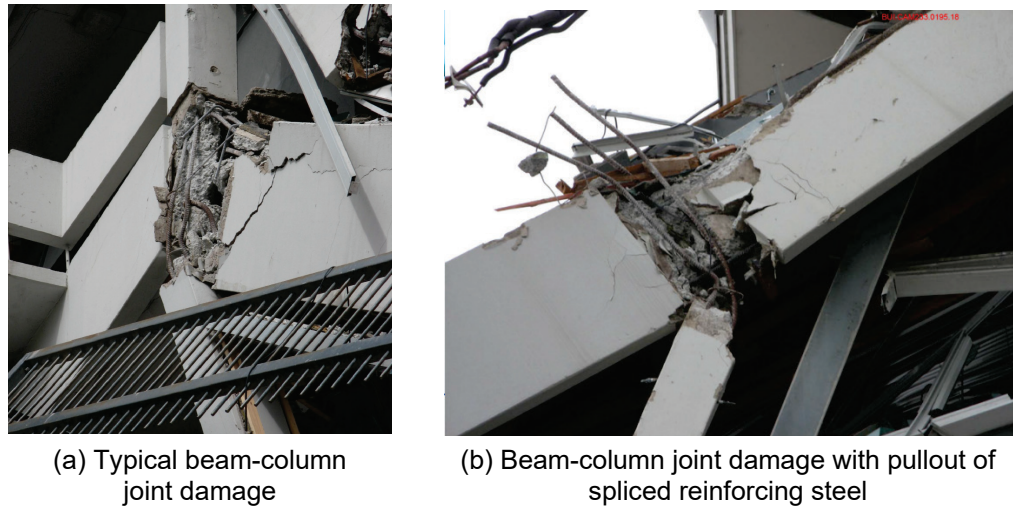
Figure 8-10   Photo of damaged beam-column joints (Jury and Sharpe, 2011).

The perimeter beam-column joints sustained significant damage as shown in Figure 8-10. The observed failures were a function of lack of confinement in the joint region and relatively short longitudinal-reinforcement splices ($24d_b$) directly above the joint region. There was no evidence suggesting obvious flexural or shear failure of the columns.

(a) Typical beam-column joint damage

(b) Beam-column joint damage with pullout of spliced reinforcing steel

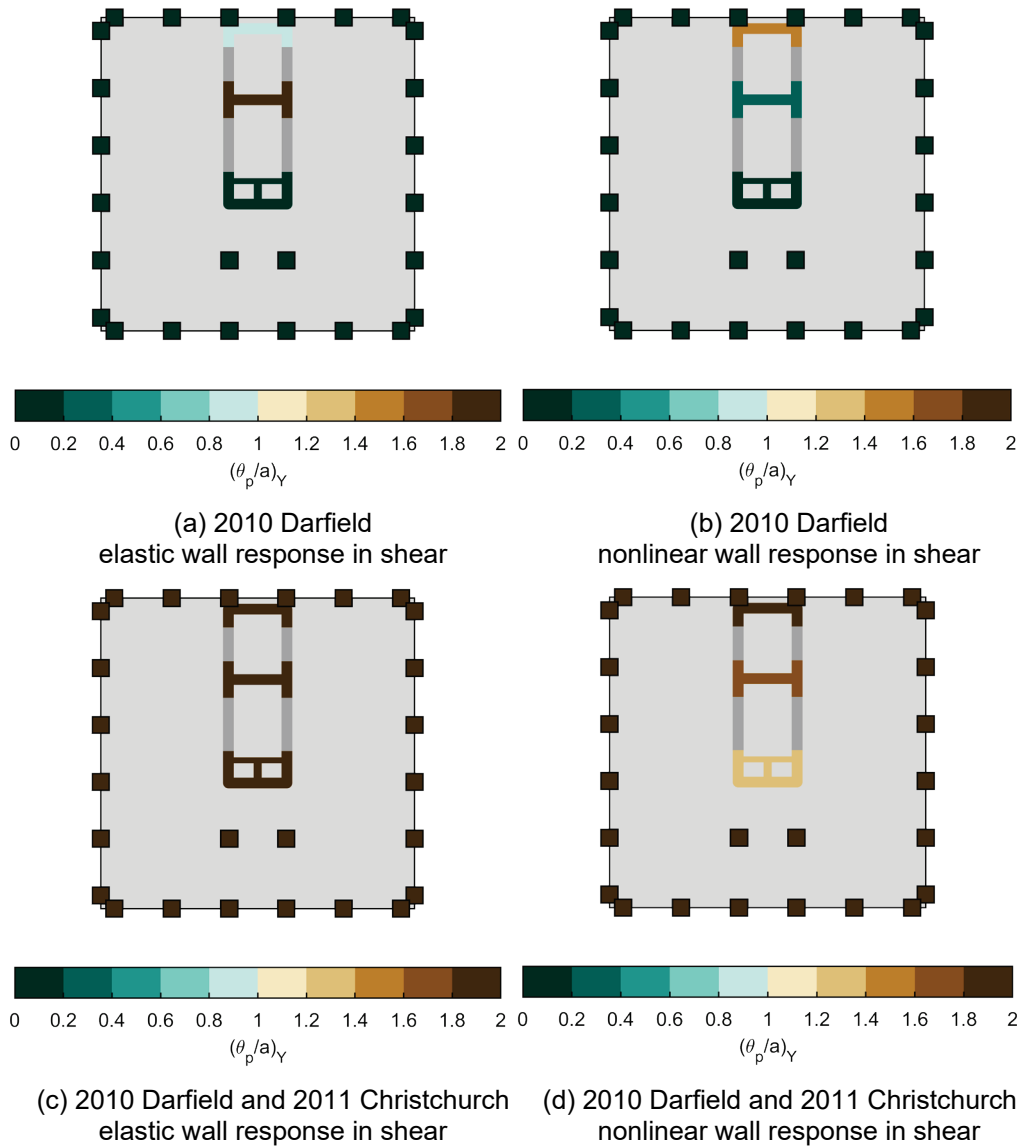
Figures 8-17 through 8-19 provide a spatial distribution of the severity of predicted column and wall damage on the basis of plastic hinge rotations relative to the ASCE 41-17 modeling parameters a and b in Figure 2-1 and the acceptance criteria at the second story. These distributions are shown for the 2010 Darfield Earthquake ground motion and 2010-2011 Canterbury Sequence (the 2010 Darfield and 2011 Christchurch ground motions in series). It is noted that no column damage was observed after the 2010 Darfield Earthquake, but some concrete spalling was identified in the box section of the core wall. For the 2010 Darfield Earthquake only, both models overpredict the level of damage to the walls but predict the lack of column damage well. In addition, it is noted that the acceptance criteria suggest collapse due to failure of the walls and columns in the 2011 Christchurch Earthquake for both models.

Figure 8-17   NDP: Heatmap of second-story column and wall plastic rotation DCRs relative to modeling parameter a in the east-west direction.
