Benchmarking Evaluation Methodologies for Existing Reinforced Concrete Buildings

Applied Technology Council

March 2022

NIST GCR 22-917-50

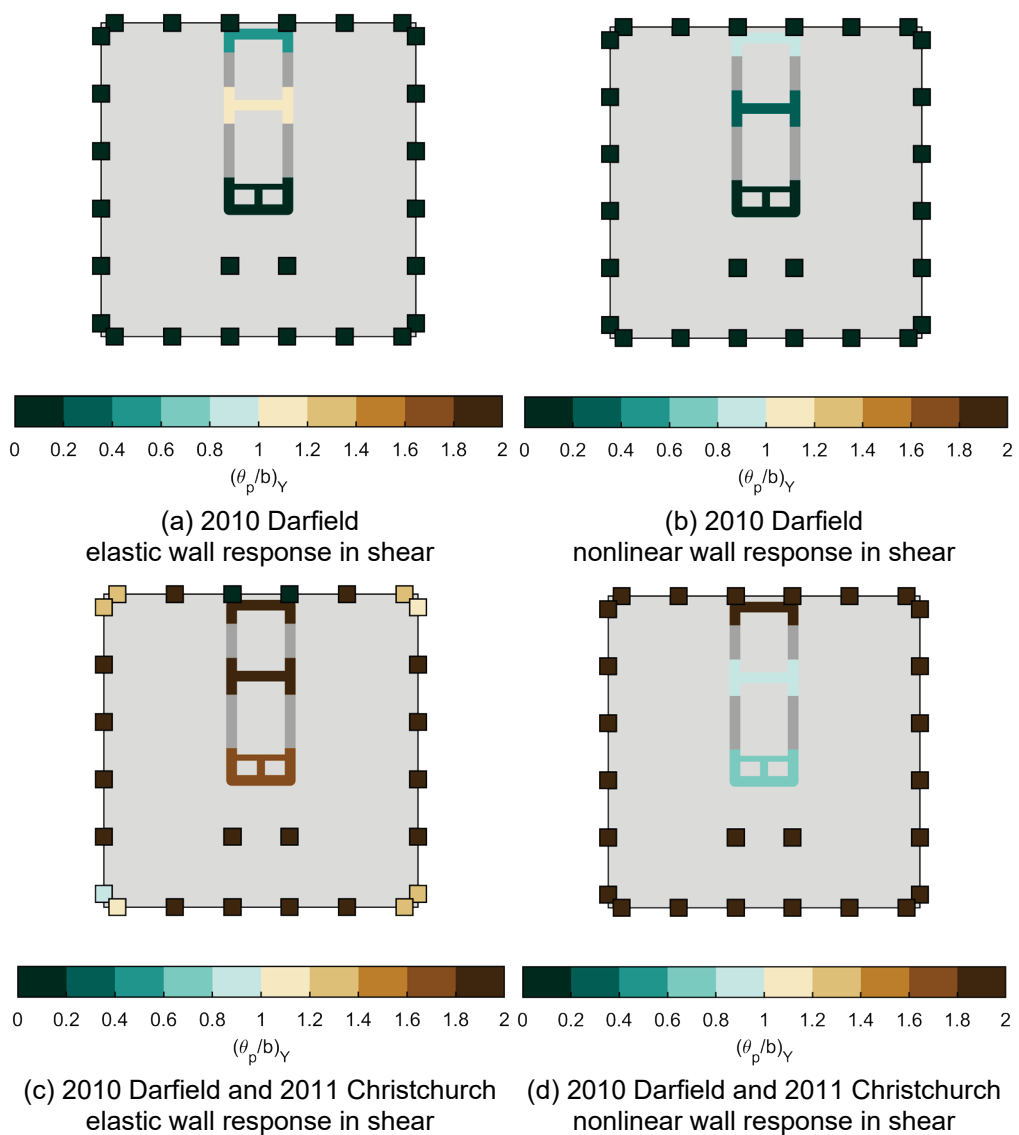
Figure 8-18   NDP: Heatmap of second-story column and wall plastic rotation DCRs relative to modeling parameter b in east-west direction.

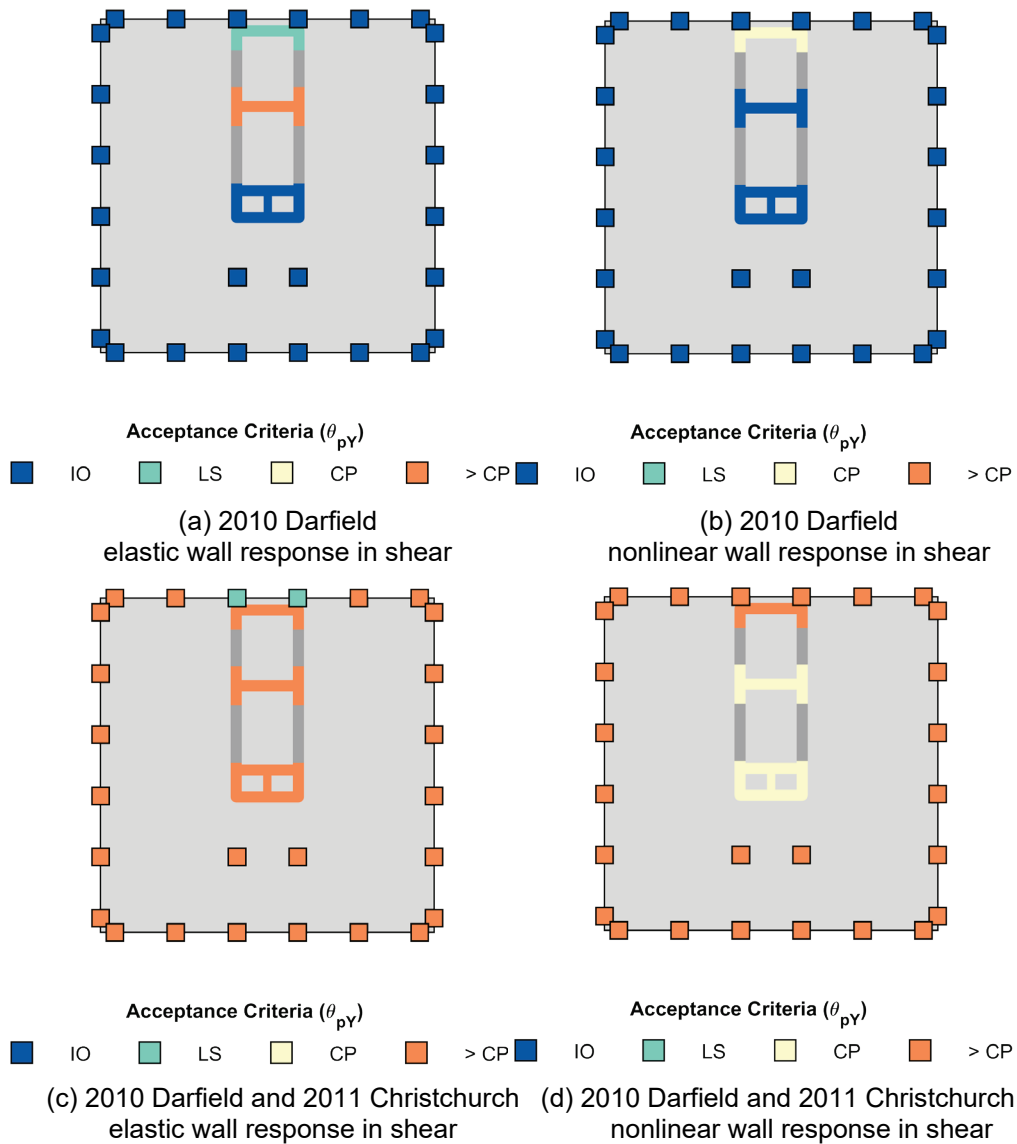
Figure 8-19   NDP: Heatmap of second-story column and wall plastic rotation
acceptance criteria in east-west direction. Shown relative to ASCE
41-17 nonlinear acceptance criteria Immediate Occupancy (IO), Life
Safety (LS), and Collapse Prevention (CP).

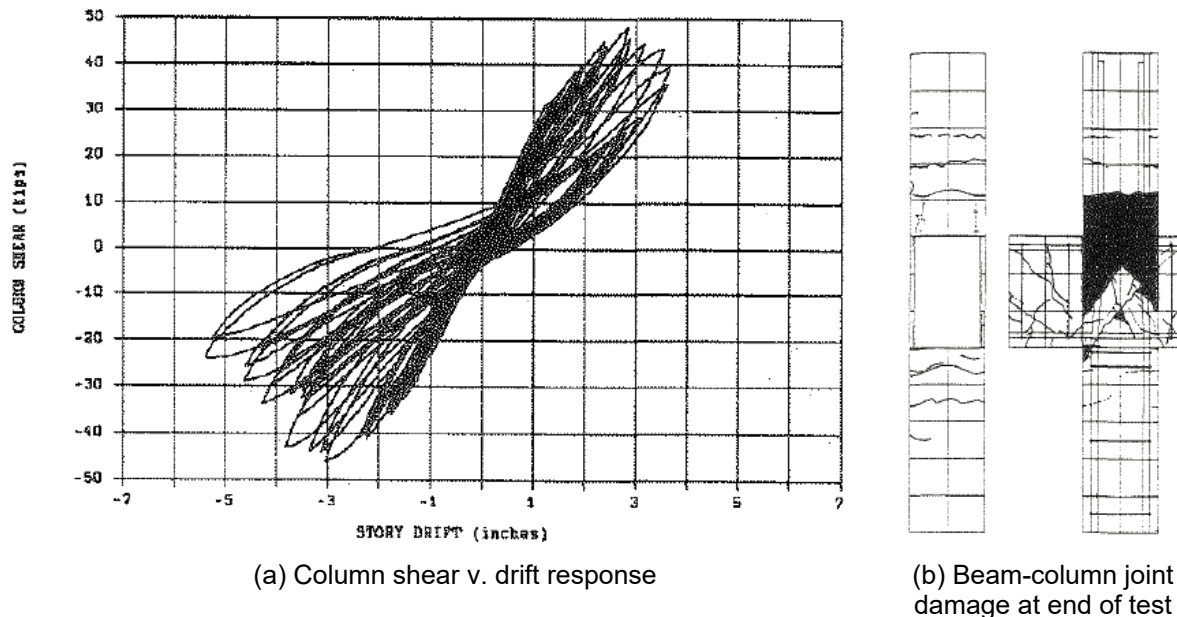
Figure 8-20   Measured hysteretic response and damage for Specimen 2 (Pessiki et al., 1990).

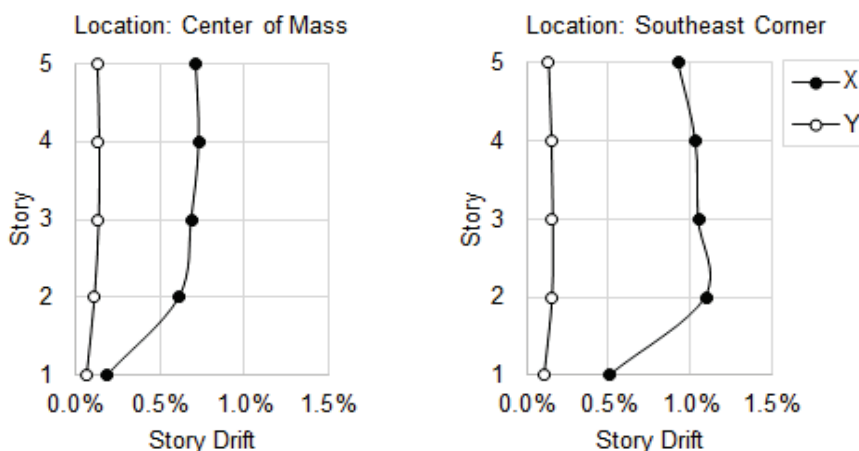
The maximum seismic story drifts results are reported in the transverse (EW, X) and longitudinal (NS, Y) directions. Figure 8-25a presents the drifts at the center of mass. The torsional response of the building in the transverse direction amplifies drifts on the southern edge of the building as can be seen in Figure 8-25b. The relatively low first story seismic drift is due to the large amount of first story shear walls. The largest drift can be seen in the transverse direction at the second story, which is where the walls failed. This is in agreement with the building response.

Figure 8-25   Linear: Maximum story drift at two different locations.

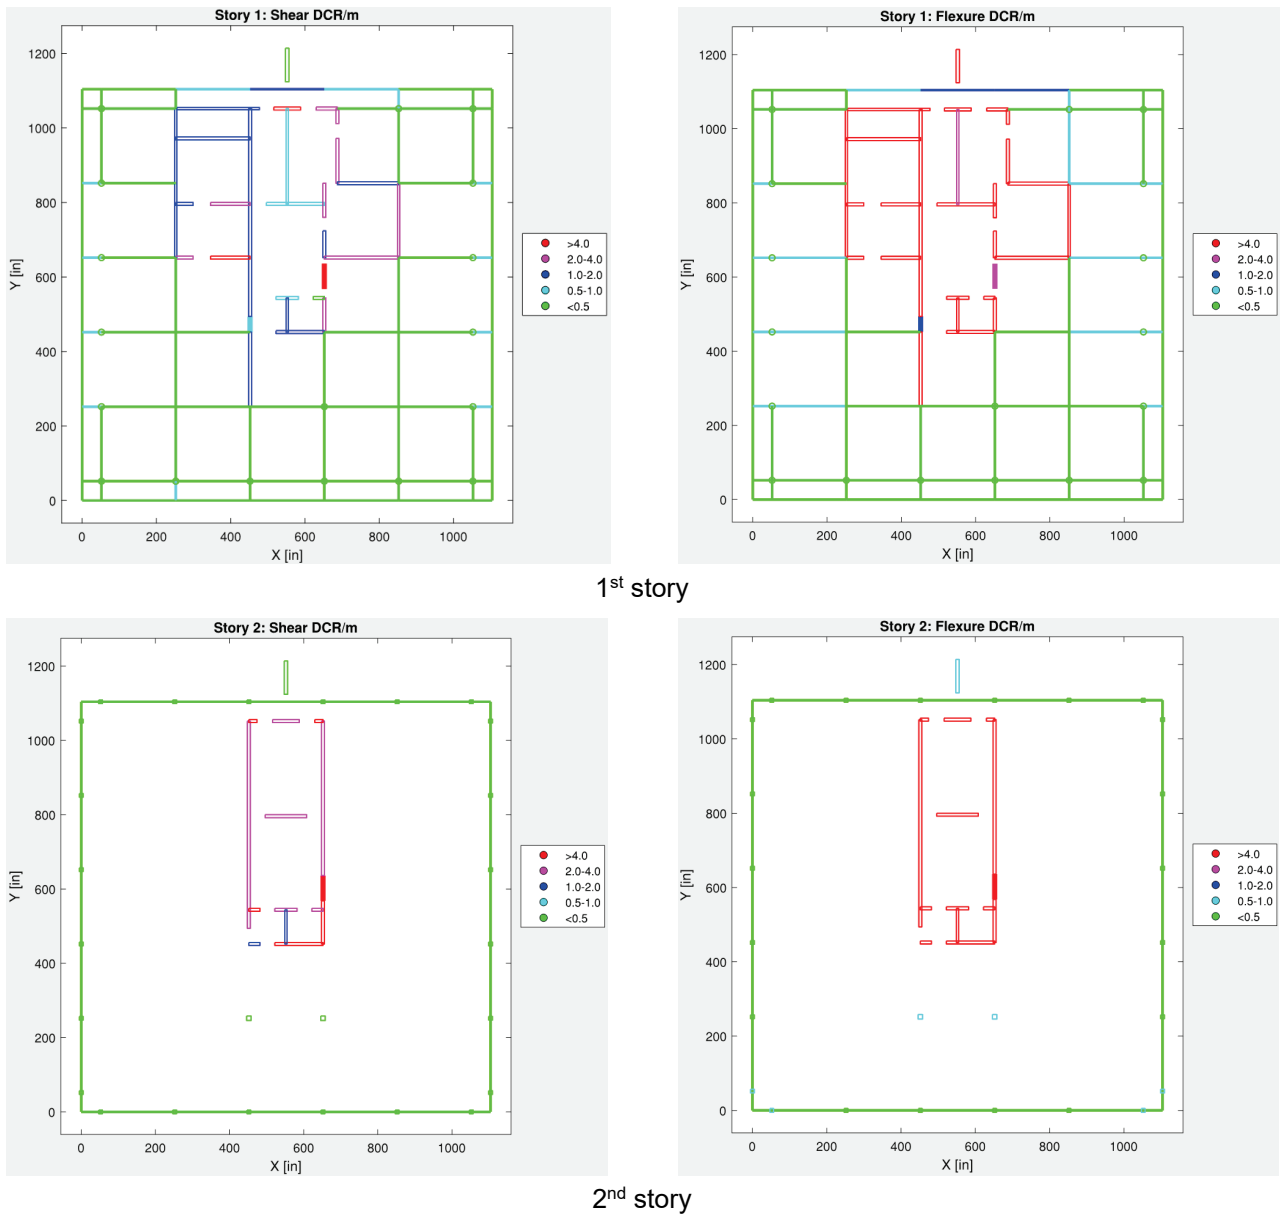
Linear analysis results for the first and second story are shown in Figure 8-26 for ground motions applied in both directions simultaneously. The shear and flexure demand-capacity-ratios (DCRs) modified by the Collapse Prevention (CP) *m*-factors are presented in the results. Those components with DCR/*m* values greater than 1.0 indicate failure to meet the CP acceptance criteria. The results show that nearly all of the frame elements meet the CP criteria while nearly all of the wall elements fail to meet the CP criteria. DCR/*m* for walls are largest in the second story in the transverse direction making these the most critical elements. This is in agreement with the most common building mechanism failure theory. Beams with poor detailing or anchorage were assigned moment releases in the model as they would be unable to contribute to the strength and post-yield stiffness of the structure. As such, results for these beams are not displayed in the following plots. Solid line type between shear wall elements indicates coupling beams.

Figure 8-26   Linear: Demand-capacity ratios for Collapse Prevention.

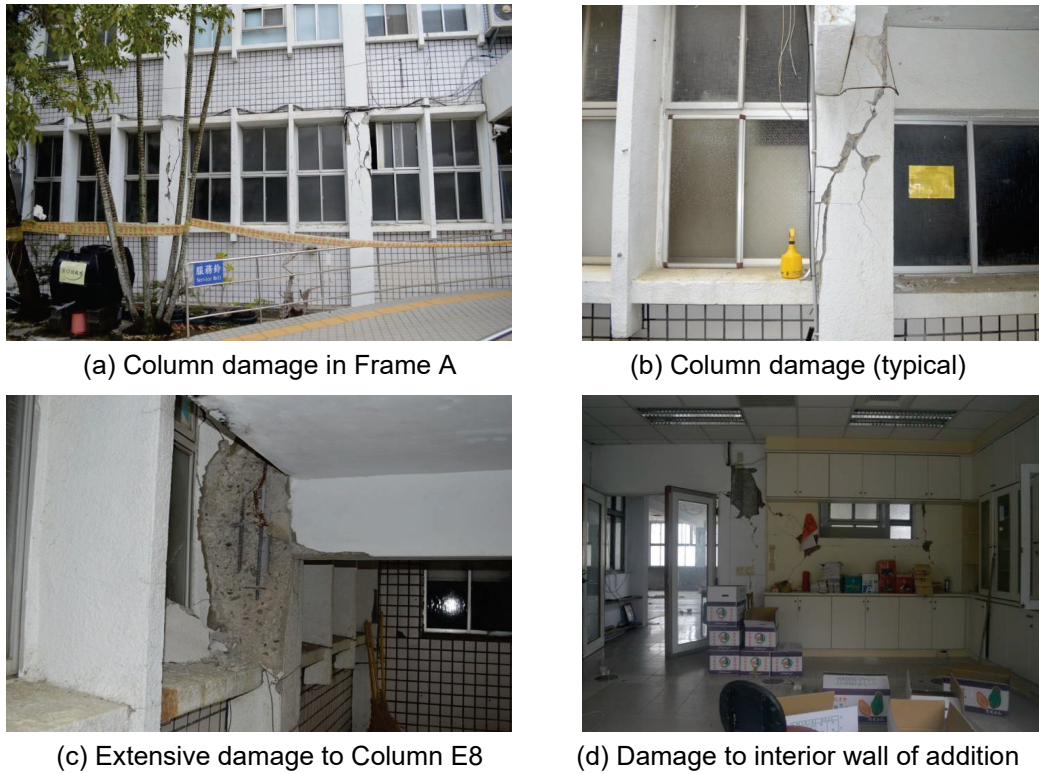
Figure 9-9   Damage to column and interior walls (Pujol et al., 2017).

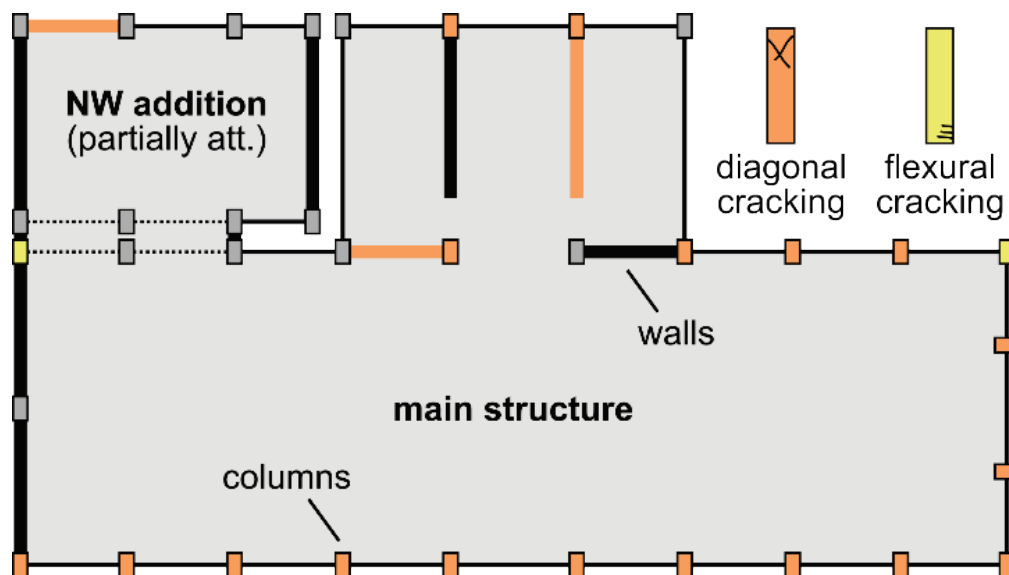
Figure 9-10   Illustration of column and full-height masonry wall damage at first story. (Damage was not observed in the walls colored black).

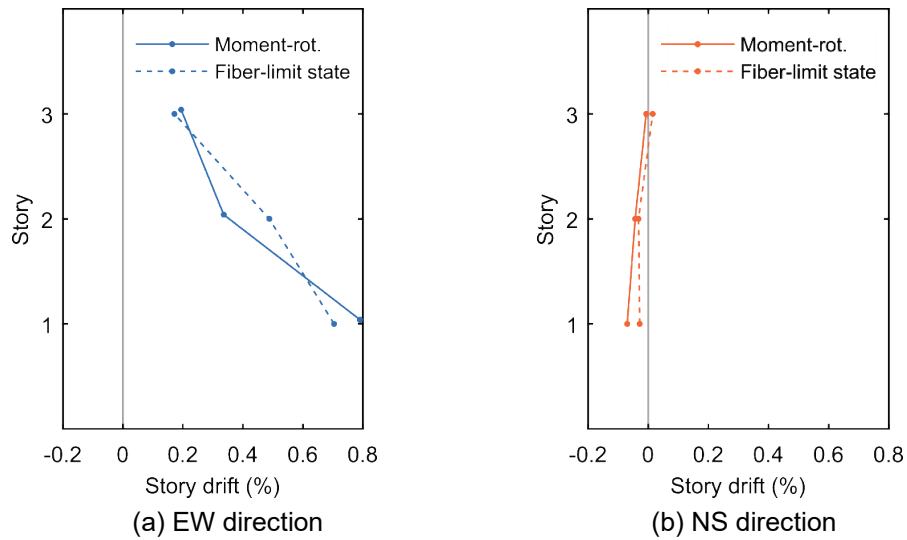
The vertical distribution of story drift in this direction is not the same for the results of each modeling approach. At the instant of maximum first story drift, the moment-rotation spring hinge model concentrates drift in the first story while the fiber-based limit-state hinge model distributes damage over the two lower stories, as shown in Figure 9-15. The soft first story mechanism predicted by the moment-rotation spring hinge model better correlates with the observed building damage.

Figure 9-15   NDP: Story drift vertical distribution at maximum first-story drift (approximately t = 9.6 sec. in both models).

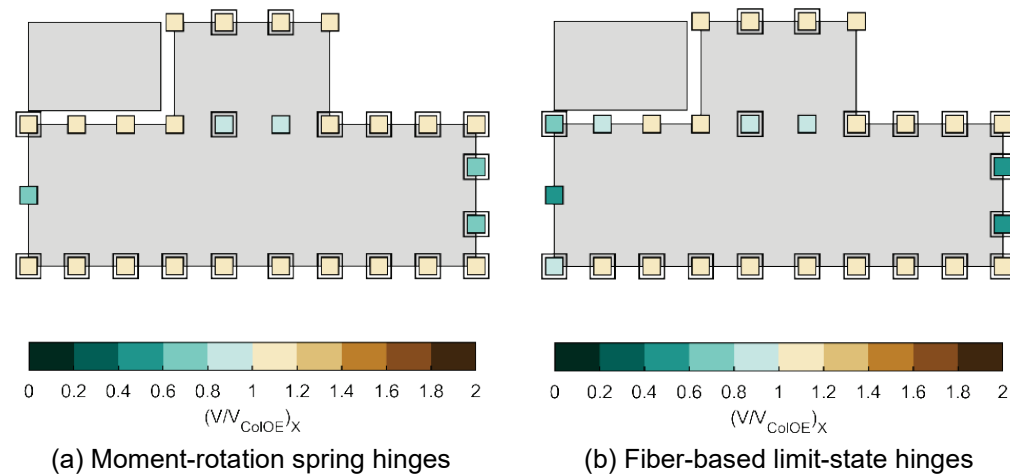
Table 9-5 summarizes the accuracy of the general column and masonry response in each model. While the predicted story drifts were somewhat lower than expected from experimental results on flexure-shear critical columns for both models, Figure 9-16 shows that most first-story columns developed their expected shear capacities, as determined using ASCE 41, under loading in the east-west direction. As shown previously, some of the observed column damage suggests flexural yielding preceded diagonal cracking due to shear, and this sequence of flexural yielding and shear failure is not simulated using the current ASCE 41 modeling provisions.

Figure 9-16   NDP: Heatmap of first-story column shear DCR in east-west direction; boxed columns indicate locations of observed damage.

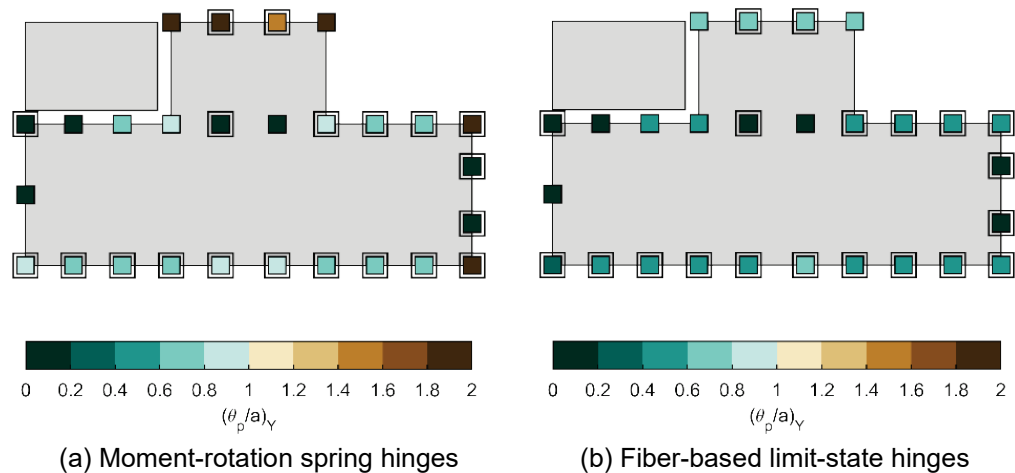
Figure 9-17   NDP: Heatmap of first-story column plastic rotation DCR relative to parameter *a* in east-west direction; boxed columns indicate locations of observed damage.

As shown in Figure 9-17, most first-story columns did not sustain rotations large enough to trigger strength degradation defined by the ASCE 41-17 modeling parameters (i.e., plastic rotation beyond *a*). In the moment-rotation spring model, 6 of 27 columns sustained strength degradation for loading in the east-west direction, although damage was only reported in 4 of these 6 columns. Significantly more columns had diagonal cracking but no predicted strength degradation from the analysis. None of the columns had rotations which exceeded *a* in the fiber-based limit-state hinge model. While the moment-rotation spring model predicts more column damage on this basis, both models underpredict the overall level of damage and do not predict the distribution of damage. Figure 9-20 shows plastic rotation demand-capacity ratios relative to parameter *b*, where it can be seen that neither model predicts axial-load failure; this is consistent with the observed building damage as axial-load failure was not experienced by the columns.

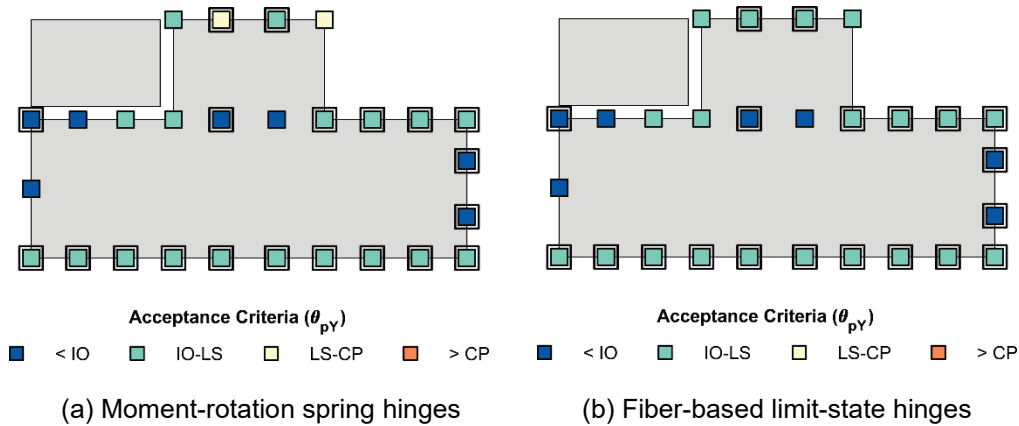
Figure 9-19   NDP: Heatmap of first-story column acceptance criteria in east-west direction; boxed columns indicate locations of observed damage.

Figures 9-19 and 9-20 summarize predicted column performance using ASCE 41 acceptance criteria. It is difficult to classify the observed damage using these criteria; nonetheless, it is clear that columns that sustained significant diagonal cracking (i.e., most first-story columns) would not meet Immediate Occupancy criteria. The simulation results indicate also that most columns would sustain damage beyond the Immediate Occupancy level. Thus, performance is well predicted on the low end, with both observation and simulation indicating most first story columns have damage exceeding that associated with Immediate Occupancy. However, limitations in the collected damage data do not support conclusions about the accuracy with which damage states beyond Immediate Occupancy are simulated.

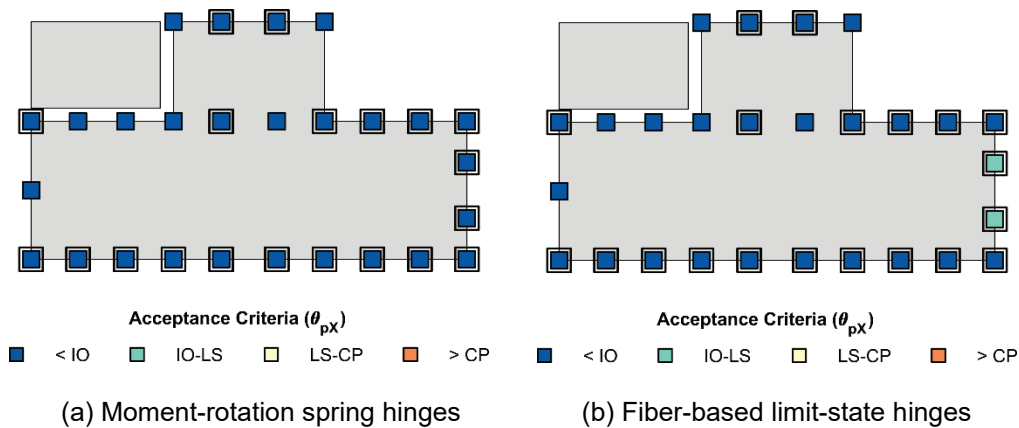
Figure 9-20   ND: Heatmap of first-story column acceptance criteria in north-south direction; boxed columns indicate locations of observed damage.

It is noted that the demands on Columns B10 and D10 exceed the Immediate Occupancy level but in the north-south direction only (transverse direction from critical direction of other columns). This is indicative of a small torsional response and consistent with the observed direction of diagonal cracking in these columns.

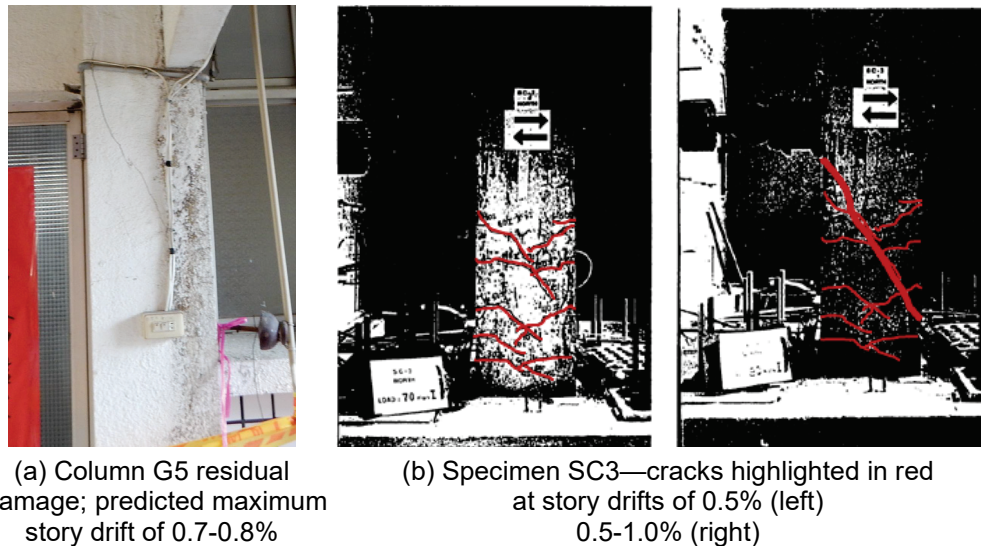
Figure 9-23   Comparison of observed column damage in building to Specimen SC3 (Aboutaha, 1994).

Figure 9-23 compares photographs of observed damage in Column G5 and Specimen SC3 at similar drift levels. Column G5 had residual diagonal cracking as shown in Figure 9-23a, though this was less severe than that observed in Columns A5 and E5. At 0.5-1.0% story drift, Specimen SC3 exhibited cracking (Figure 9-23b) that was more extensive than that observed in Column G5. However, it must be noted that the photograph of Column G5 was taken at a residual (i.e., unloaded) state in the building, while the specimen photograph was taken under load at an imposed drift in the experiment. Thus, the cracks in Figure 9-23b would be expected to be wider and more easily distinguishable at comparable maximum drift levels. The hysteretic response of Specimen SC3 is plotted in Figure 9-24a, which suggests that damage at these drift levels would not be associated with strength degradation. This is generally consistent with both the moment-rotation spring and fiber-based limit-state hinge model results, as well as the observed damage in Column G5.

(a) Column G5 residual damage; predicted maximum story drift of 0.7-0.8%

(b) Specimen SC3—cracks highlighted in red at story drifts of 0.5% (left) 0.5-1.0% (right)

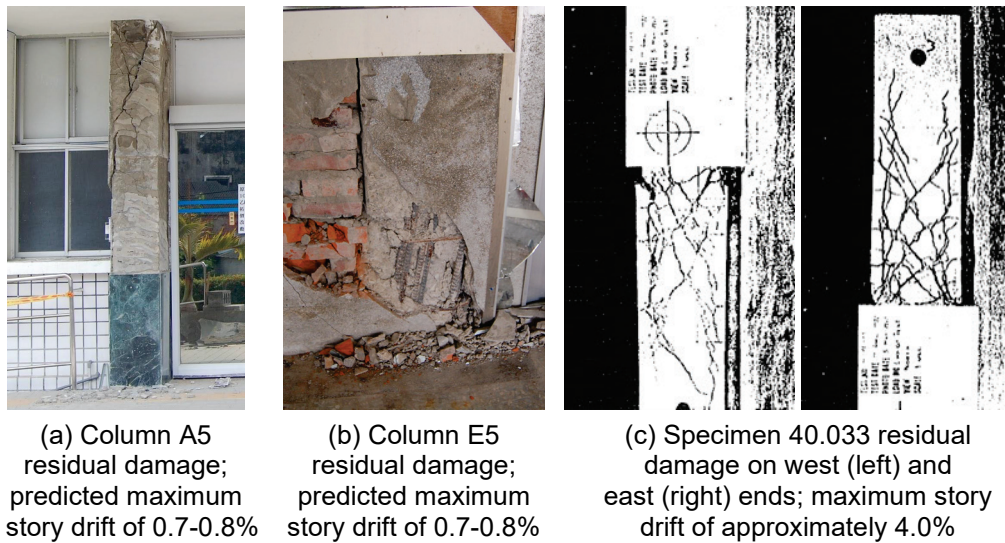
Figure 9-25   Comparison of observed column damage in building to Specimen 40.033 (Wight and Sozen, 1973).

Figure 9-25 compares observed residual damage from Columns A5 and E5 to that of Specimen 40.033. Column A5 sustained diagonal cracking with wide residual crack openings (Figure 9-25a). Column E5 had more extensive concrete spalling at its base after undergoing approximately the same drift demands (maximum story drift demands of 0.7%-0.8%). The increased damage severity versus that observed in Column E5 is attributed in part to the higher axial load demands on these columns. Despite the greater damage to Column E5, essentially elastic behavior was predicted in the nonlinear analyses (see Figures 9-21b and 9-22b). Note that Column A5 had partial-height masonry infill that created a captive-column condition, while Column E5 was adjacent to full-height masonry infill on one side. The response of Column E5 may be affected by the adjacent masonry infill, which is visibly damaged in Figure 9-25a. Specimen 40.033 had similar column properties, but the only photographic evidence of damage available is after loading to approximately 4.0% drift, which is well over the predicted drift demands on the building. Thus, it is

difficult to draw comparisons between Columns A5, E5, and Specimen 40.033 based on reported damage alone. The hysteretic response of Specimen 40.033 is shown in Figure 9-24b. These plots show that strength degradation in this specimen did not occur until approximately 4.0% drift, which is well above the predicted drift demands from the analysis. Although the observed damage does not indicate significant strength degradation, the level of residual cracking and spalling does indicate more inelastic action than implied by the simulated response (Figures 9-21 and 9-22) and the experimental response at the same drift level (Figure 9-24b). This comparison suggests the maximum drift is under predicted in the analysis, which may be due to the inconsistency between the site ground motion and best estimate ground motion used in the simulation.

| (a) Column A5 residual damage; predicted maximum story drift of 0.7-0.8% | (b) Column E5 residual damage; predicted maximum story drift of 0.7-0.8% | (c) Specimen 40.033 residual damage on west (left) and east (right) ends; maximum story drift of approximately 4.0% |

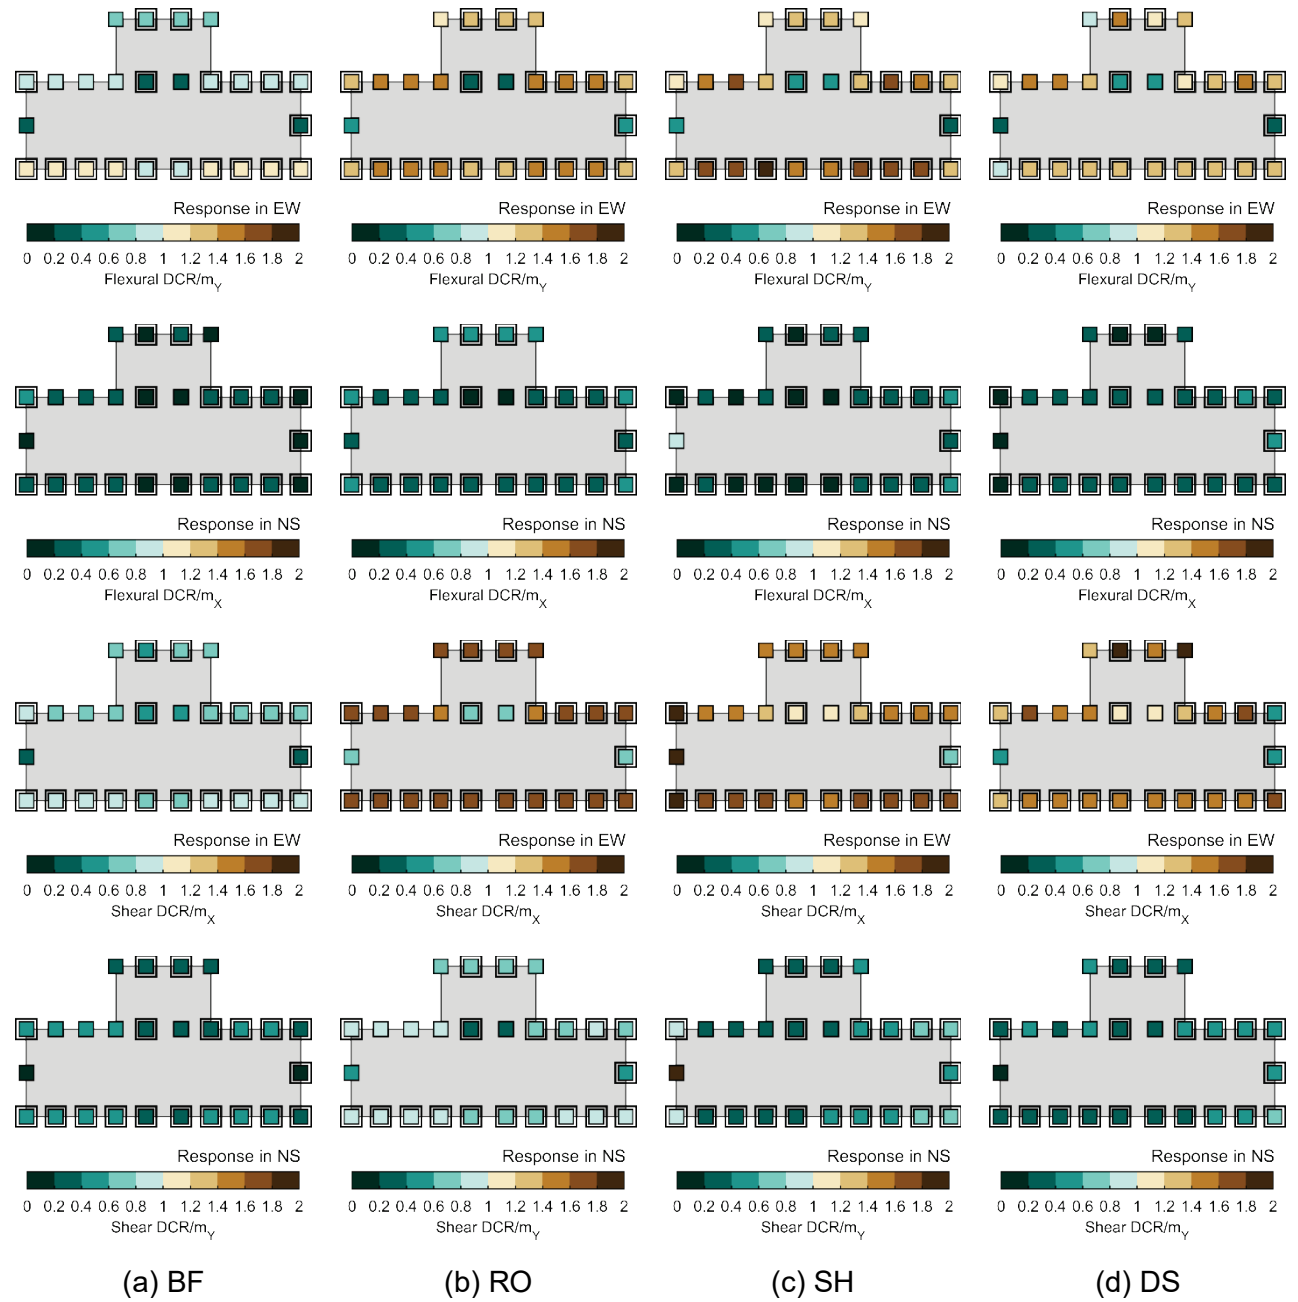
Figure 9-27   LDP: Heatmap of first-story flexural and shear DCR/*m* values; boxed columns indicate locations of observed damage.

Figure 9-27 shows the results for the four models in terms of predicted damage and observed damage, where the column was predicted to be damaged if the flexural or shear demand capacity ratio (expressed in terms of *m* for Collapse Prevention for the flexural capacity) exceeds 1. Note that axial-flexural interaction was considered to compute the flexural capacity, but biaxial bending was not evaluated; neglecting biaxial bending was deemed appropriate as it was only expected to increase the DCR for flexure, which exceeded 1 (see second and third bullet). The following statements can be made:

- None of the models predict DCR_m values exceeding 1 in the Y-direction. This is consistent with the observed damage.

- In the bare frame (BF) model, the predicted flexural DCR_m is approximately or slightly larger than 1.0 in some of the damaged columns but less than 1 for most. The predicted shear DCR_m is less than 1 for all of the columns (both damaged and undamaged).

- For all of the models that include the masonry infill, the predicted flexural DCR_m exceeds 1 in the overwhelming majority of the damaged columns. This type of damage is consistent with photographs that show spalling (indicative of flexural damage) in many of the photographs of the first-story columns, as shown in Figure 9-10a indicating the flexural strength was developed. However, the severity of damage (i.e., beyond Collapse Prevention performance) is over-predicted by the simulation.

- A similar observation is made for the predicted shear DCR_m, where the majority of the columns that sustained damage in the form of diagonal cracking had shear DCR_m values that exceeded 1. This suggests shear failure controlled or followed flexural yielding, the latter being more consistent with the observed damage type (Figure 9-10). The analysis predicts more severe damage than observed.

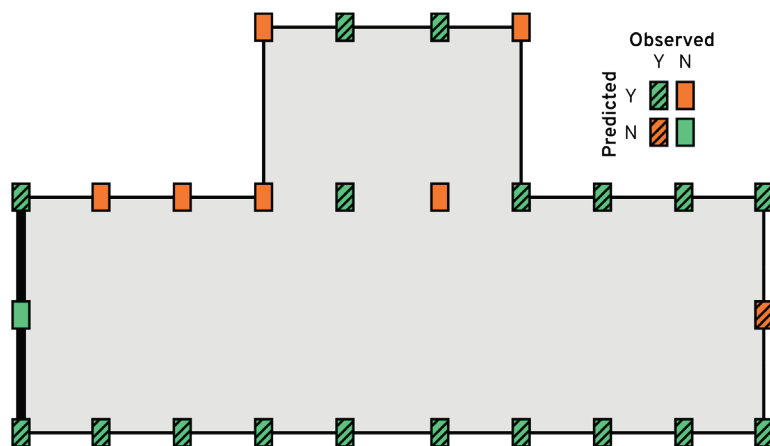
Figure 9-28   LDP: Spatial comparison of predicted versus observed damage based on flexure and shear limit states (data are consistent for all ASCE 41-compliant models).

- Figure 9-28 shows the accuracy of the prediction of exceeding the allowable strength, which are indicative of damage and failure mode. The results show that the BF model does not predict the failure model correctly of any of the columns.

- The models that include masonry infill all predict similar distributions of damage that are more accurate than that of the bare frame model. Figure 9-28 visualizes the accuracy in terms of the gross damage observed or not observed of the SH and DS models, which have the same damage distribution.

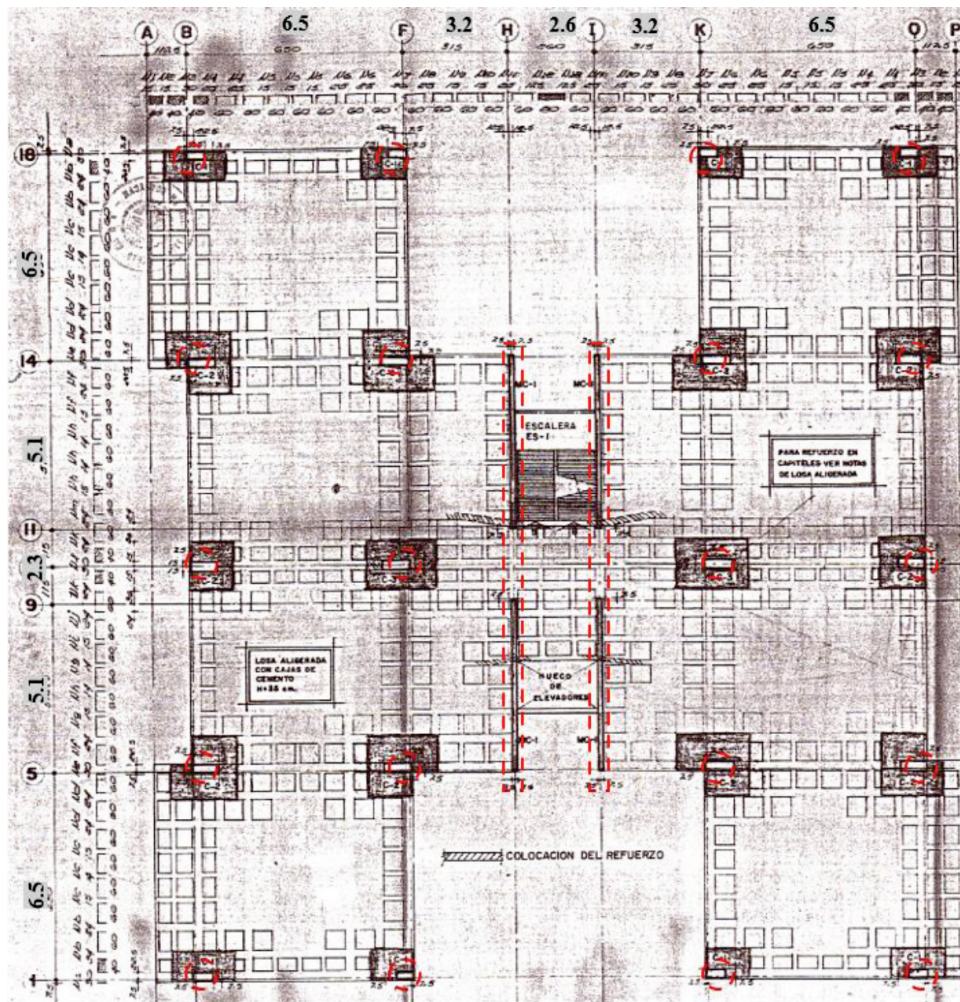
Figure 10-12   Structural damage observed in the building after the 2017 Puebla Earthquake (Dirac Ingenieros Consultores, 2019b).

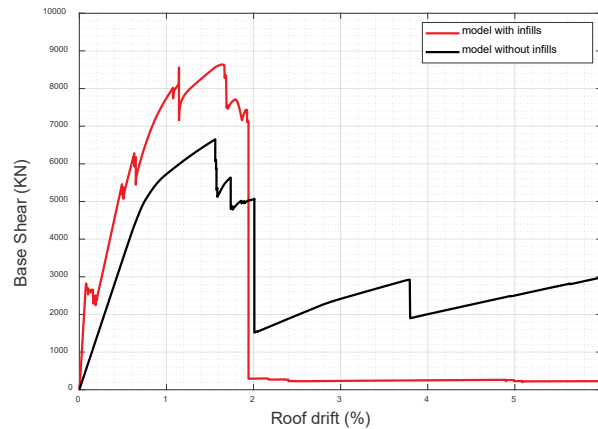
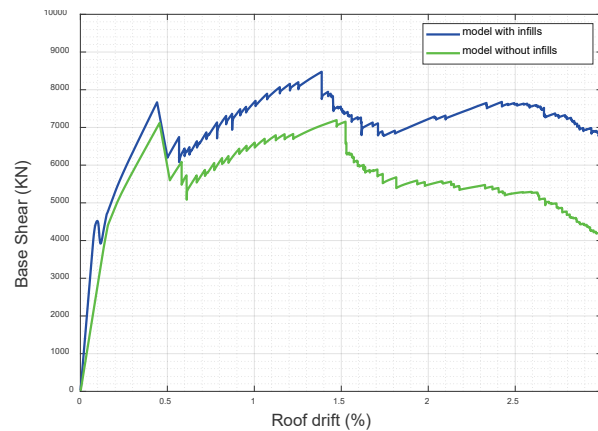
Pushover analyses were performed for models with and without masonry elements, in both the frame and the wall directions, to evaluate the effect of the masonry on strength and deformation capacity of the frames (Figure 10-35). As expected, the stiffness and base shear capacity of the building were higher for the model with masonry infills. In the frame direction, both models experienced a sudden loss of lateral load capacity at a mean drift ratio of approximately 2%. The similarity in the shape of the pushover curve is a result of the nonductile behavior of both columns and masonry walls. The main difference between the two is that the model with masonry walls had approximately 35% higher base shear capacity than the model where the effect of the masonry walls was neglected.

In the concrete wall direction behavior was much more ductile as a result of the dominant behavior of the concrete walls, and the strength of the two models was very similar. Columns were modeled so they would retain axial capacity with zero stiffness when exceeding the plastic rotation corresponding to modeling parameter b so the pushover curves shown in Figure 10-35b do not capture column axial failure.

Figure 10-35   Pushover analysis results in (a) frame direction and (b) wall direction.

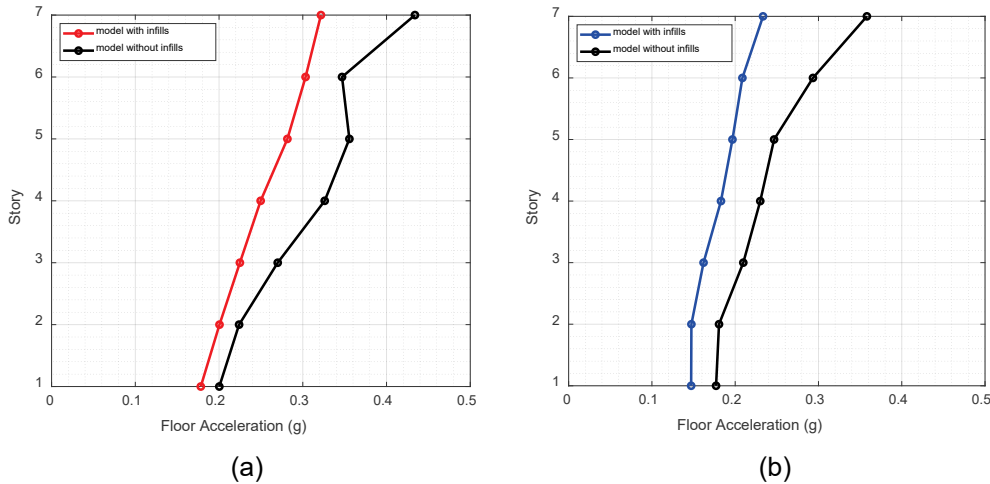
The simulated and observed performance of the building are compared in this section. Performance metrics for the 2017 Puebla Earthquake record at Jardín de Niños station are plotted for the model with and without masonry infills in Figures 10-36 and 10-37. Figure 10-37 shows that drift ratios were low in both directions, but significantly lower in the wall direction (north-south). Peak drift ratio in the frame direction of the model with masonry elements was approximately 0.50%, compared with almost 3% for the model without masonry elements. The large difference between the two shows that masonry walls and partitions contributed significantly to reduce drift demands in the frame direction.

Figure 10-36   Acceleration profiles calculated with nonlinear model including masonry walls and infills for the 2017 Puebla Earthquake (a) frame direction, and (b) wall direction.

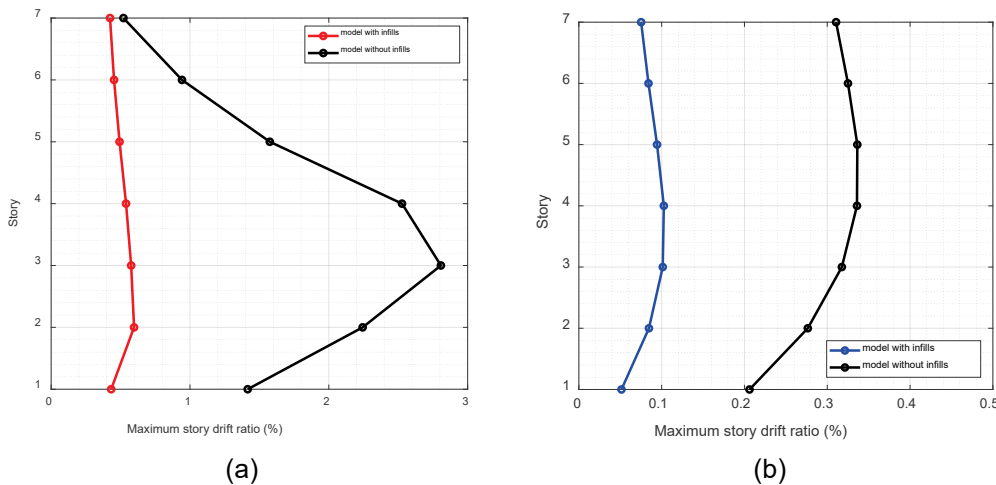
Figure 10-37   Drift ratio profiles calculated with nonlinear model including masonry walls and infills for the 2017 Puebla Earthquake (a) frame direction, and (b) wall direction.

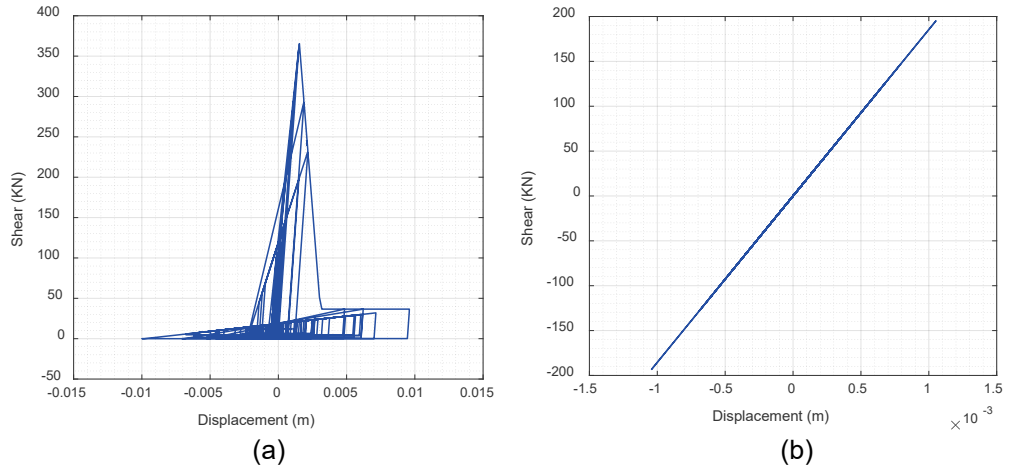
All members, except masonry infill struts (Figure 10-38a) in the frame and wall directions, remained in the linear range of response. Façade masonry elements (Figure 10-38b) remained in the linear elastic range even though significant damage was observed in the building.

Figure 10-38   Hysteretic response of (a) first story masonry infill and (b) façade masonry element for the 2017 Puebla Earthquake.

Observed damage included significant damage to masonry walls (Figures 10-15 to 10-20) in multiple stories and locations, both in the interior and exterior of the building. This is in direct contrast to the calculated response, which was accurate only in estimating severe damage (Figure 10-38a) to the infill struts (Figures 10-16 through 10-18). Because the model estimated damage to masonry walls in far fewer locations than was observed, the model was unconservative estimating the spatial distribution of damage to masonry infill and partitions.

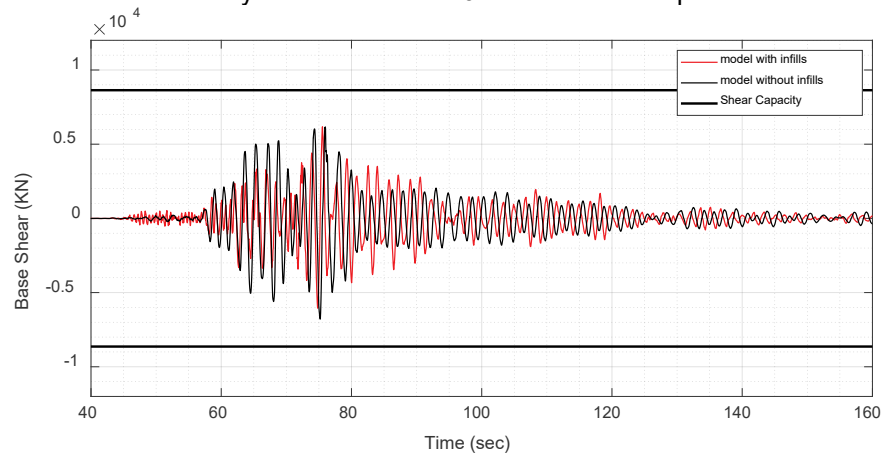
Calculated base shear histories for the 2017 Puebla Earthquake are shown in Figures 10-39 and 10-40, where black horizontal lines show the base shear strength calculated with the pushover analyses (Figure 10-35). In both the frame and wall directions, calculated base shear demands were significantly lower than the calculated base shear strength, which confirms that calculated demands were not high enough to cause significant damage.

Figure 10-39   Base shear history in the frame direction.

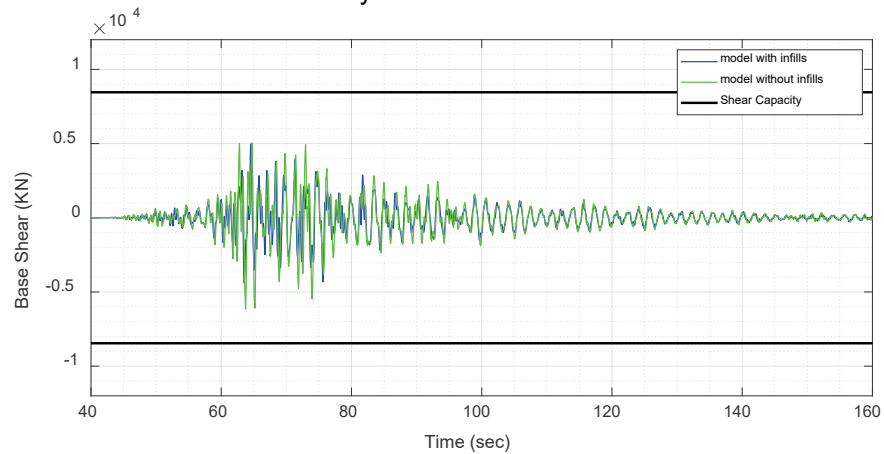
Figure 10-40   Base shear history in the wall direction.

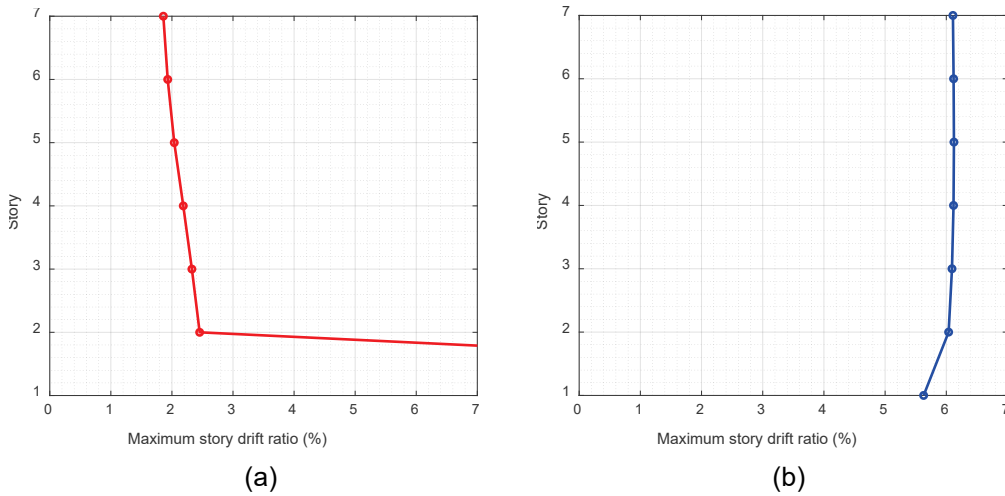
Figure 10-42   Drift ratio profiles for (a) frame and (b) wall direction calculated with
                  nonlinear model including masonry walls and infills for the 2017
                  Puebla Earthquake scaled to the MCE uniform hazard spectrum.

were completely uncoupled, so damage in the weak direction of the wall did not affect its behavior in the strong direction. Figure 10-42b shows that the intensity of shaking for the MCE level event would have been sufficient to cause severe damage to the wall due to excessive rotations in the weak direction.

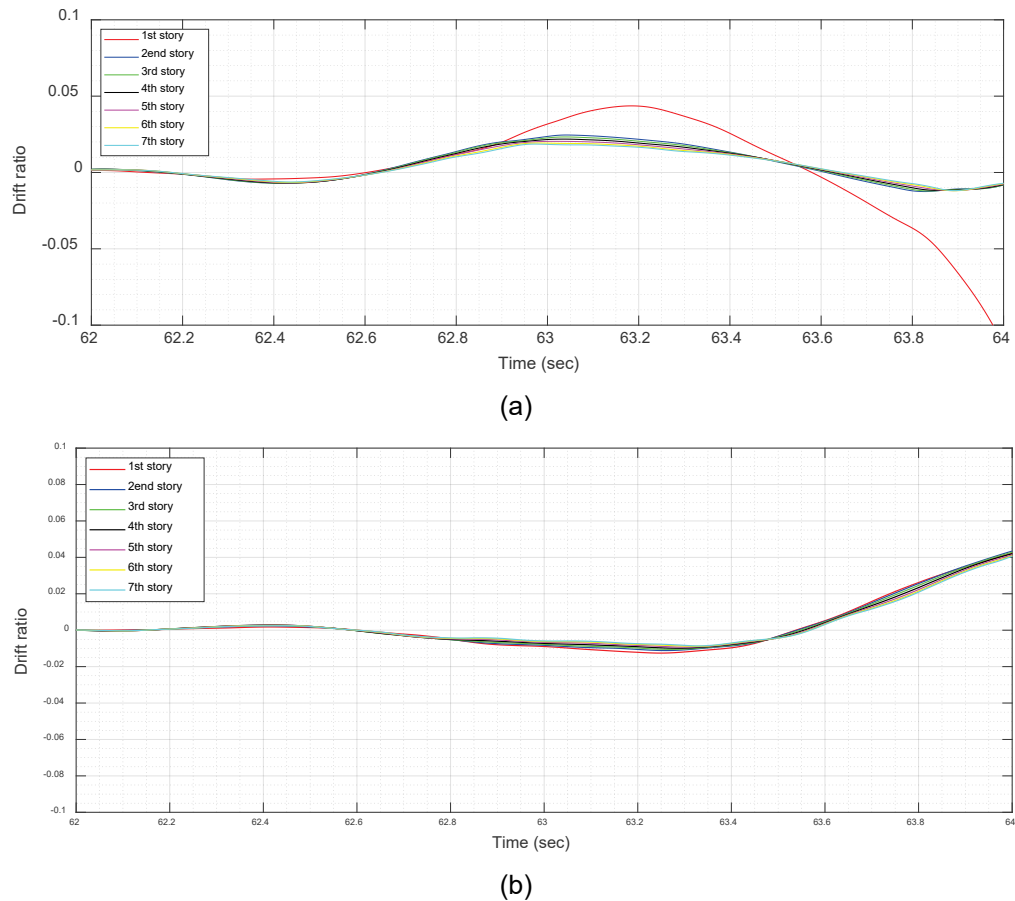
Figure 10-43 shows drift ratio histories in the frame (Figure 10-43a) and wall directions (Figure 10-43b), respectively, at the onset of building collapse. Drift ratio histories shown in this figure provide a clear indication of the global behavior that led to the collapse of the building. Masonry walls at the first floor in the frame direction lost lateral load capacity at or before a time of 62.9 sec., increasing building flexibility and placing a significant demand on the columns. The columns, which were shear critical in the frame direction, were severely damaged due to the deformation demand, precipitating the collapse of the building. Figure 10-43b shows that between 62 sec. and 64 sec., the maximum drift ratio in the wall direction was approximately 4%, which the pushover analysis in Figure 10-35b shows would have been sufficient to heavily damage the wall, pushing it into unstable behavior. The simulation indicates that excessively large deformations of the building in the frame direction would have likely triggered collapse in the wall direction.

Figure 10-43   Drift ratio histories for (a) frame and (b) wall direction calculated with nonlinear model including masonry walls and infills for the 2017 Puebla Earthquake scaled to the MCE uniform hazard spectrum.

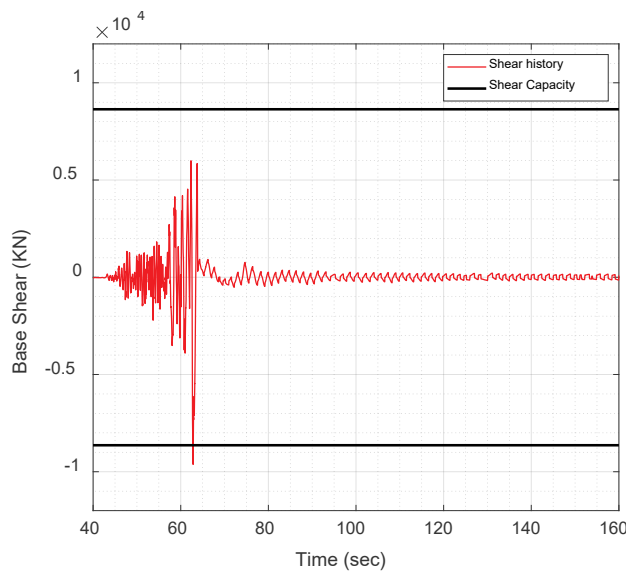
Calculated base shear histories for the MCE level hazard are shown in Figures 10-47 and 10-48, where black horizontal black lines correspond to the base shear strength calculated using a pushover analysis. In both the frame and wall directions, calculated base shears exceeded the base shear strength, which shows that calculated demands were high enough to inflict significant damage. According to the Figure 10-44, collapse initiated at approximately 63 seconds, when the drift ratio in the first story started to become significantly larger than in all others. Base shear histories show that this time coincides with peak base shear demands in the frame (Figure 10-47) and wall (Figure 10-48) directions. Base shear histories calculated after 64 seconds are not meaningful because it is likely the model would have collapsed already.

Figure 10-47   Base shear in the frame direction for the 2017 Puebla Earthquake scaled to the MCE uniform hazard spectrum.
