Benchmarking Evaluation Methodologies for Existing Reinforced Concrete Buildings

Applied Technology Council

March 2022

NIST GCR 22-917-50

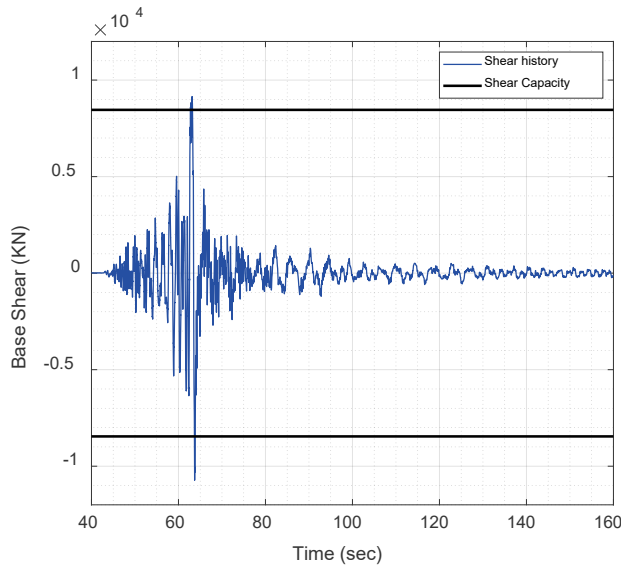
Calculated base shear histories for the MCE level hazard are shown in Figures 10-47 and 10-48, where black horizontal black lines correspond to the base shear strength calculated using a pushover analysis. In both the frame and wall directions, calculated base shears exceeded the base shear strength, which shows that calculated demands were high enough to inflict significant damage. According to the Figure 10-44, collapse initiated at approximately 63 seconds, when the drift ratio in the first story started to become significantly larger than in all others. Base shear histories show that this time coincides with peak base shear demands in the frame (Figure 10-47) and wall (Figure 10-48) directions. Base shear histories calculated after 64 seconds are not meaningful because it is likely the model would have collapsed already.

Figure 10-48   Base shear in the wall direction for the 2017 Puebla
Earthquake scaled to the MCE uniform hazard spectrum.

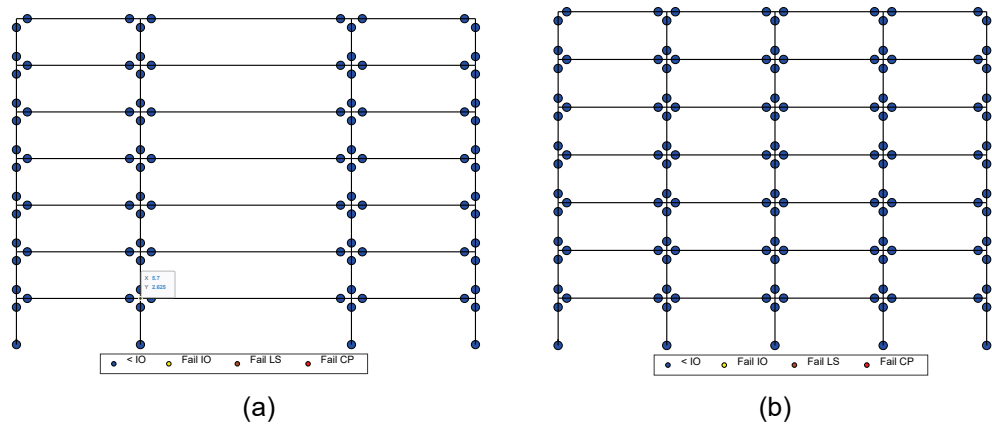
Performance levels for the 2017 Puebla Earthquake are shown in Figure 10-50a for
the frame in Gridline 10 (frame direction) and in Figure 10-50b for Gridline O (wall
direction). All beam and column elements in the two frames had a performance level
of IO, in large part due to the lateral loads carried by the masonry walls and infill.

Figure 10-50   Element performance levels for the 2017 Puebla Earthquake: (a)
                Gridline 10 in the frame direction (east-west), and (b) Gridline O in
                the wall direction (north-south). Shown relative to ASCE 41-17
                nonlinear acceptance criteria Immediate Occupancy (IO), Life Safety
                (LS), and Collapse Prevention (CP).

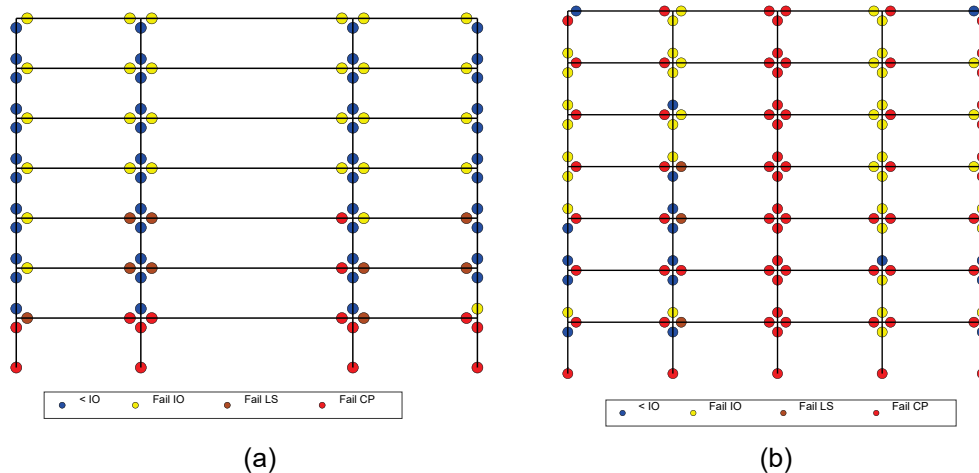
Performance levels for the 2017 Puebla Earthquake scaled to the MCE hazard level
are shown in Figure 10-51a for the frame in Gridline 10 (frame direction) and in
Figure 10-51b for Gridline O (wall direction). As expected, all beam and column
elements in frame and wall directions showed substantially greater damage than for
the unscaled record. The most useful observation from Figure 10-51a is that damage
was largest in first story columns, clearly showing the formation of a collapse
mechanism.

Figure 10-51   Element performance levels for the 2017 Puebla Earthquake scaled to the MCE hazard level: (a) Gridline 10 in the frame direction (east-west), and (b) Gridline O in the wall direction (north-south). Shown relative to ASCE 41-17 nonlinear acceptance criteria Immediate Occupancy (IO), Life Safety (LS), and Collapse Prevention (CP).

Damage distribution in the wall direction is more difficult to interpret, but shows the most severe damage concentrated in the center column, which was the least protected by masonry beams and columns.

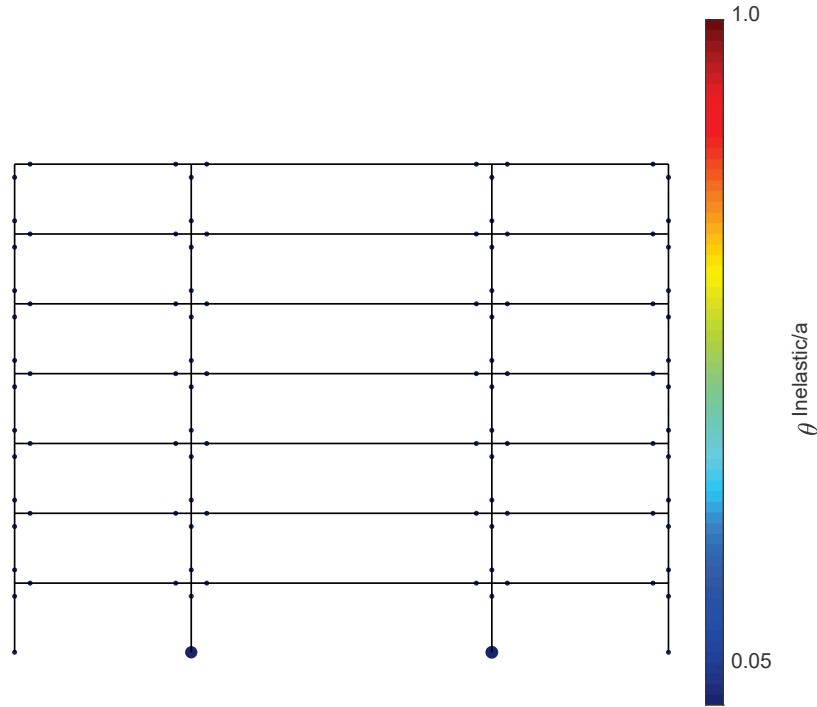
This second damage indicator (ratio of $\theta_{inelastic}$ to modeling parameter a) is shown in Figures 10-52 through 10-55 for the two frames shown in Figure 10-49. Results for this second metric are consistent with performance levels shown in Figures 10-50 and 10-51. For the 2017 Puebla Earthquake, inelastic rotations in beams and columns are zero or very small. As shown in Figure 10-41, although they exceeded their flexural cracking moment, reinforced concrete walls remained below yield, so their plastic rotation was zero. Damage estimates to beams and columns inferred from Figures 10-50 and 10-51 are in good agreement with observed damage after the 2017 Puebla Earthquake described in Section 10.2.4, which shows damage consisting of narrow

Figure 10-52   Ratio of inelastic rotation to modeling parameter *a* for the 2017 Puebla Earthquake, Gridline 10 in the frame direction (east-west).

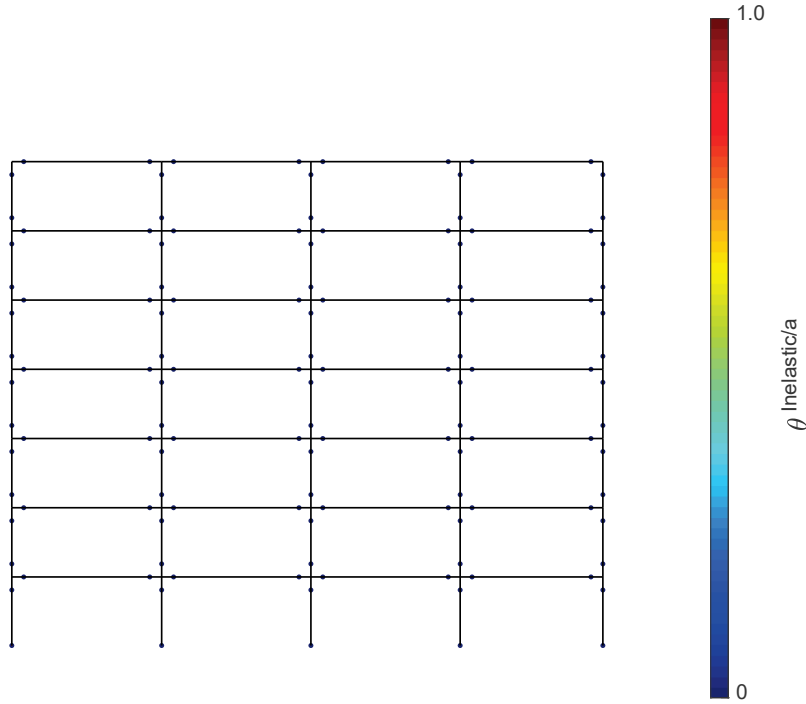
Figure 10-53   Ratio of inelastic rotation to modeling parameter *a* for the 2017 Puebla Earthquake, Gridline O in the wall direction (north-south).

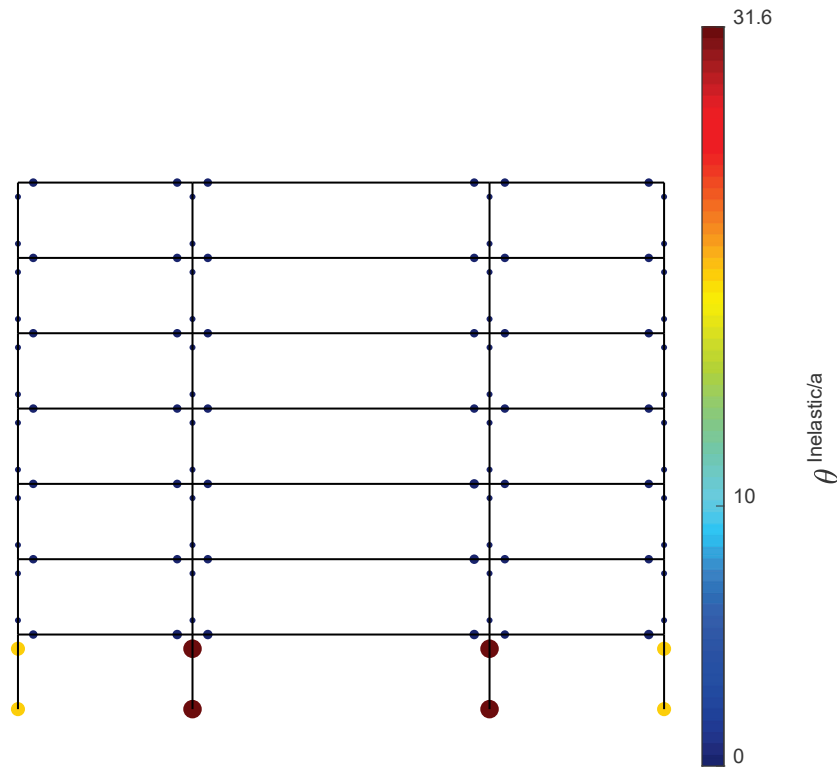
shear cracks in columns (Figure 10-13) and loss of shell and some buckling in one of the reinforced concrete walls (Figure 10-14). For the MCE level hazard, significant damage was found in multiple beams and columns of the model throughout the building. Figure 10-54 shows that in the frame direction a story mechanism formed in the first story of the model, which is consistent with the damage pattern in Figure 10-51a and the drift ratios shown in Figure 10-43. Figure 10-55 shows that inelastic demands were largest in the center column, which is consistent with the damage pattern in Figure 10-51b.

Figure 10-54   Ratio of inelastic rotation to modeling parameter *a* for the 2017 Puebla Earthquake scaled to the MCE hazard level, Gridline 10 in the frame direction (east-west).

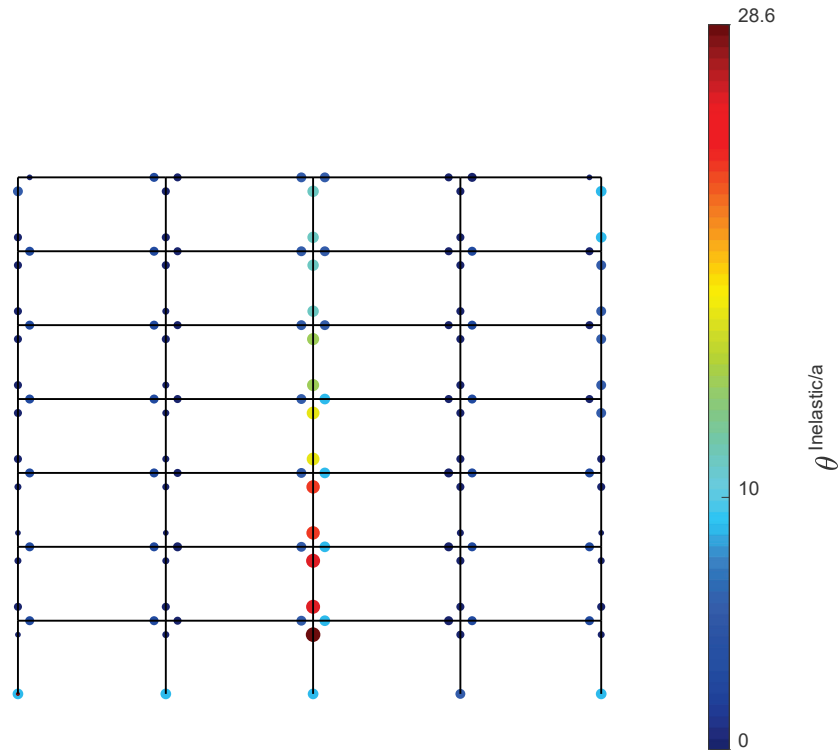
Figure 10-55   Ratio of inelastic rotation to modeling parameter *a* for the 2017 Puebla Earthquake scaled to the MCE hazard level, Gridline O in the wall direction (north-south).

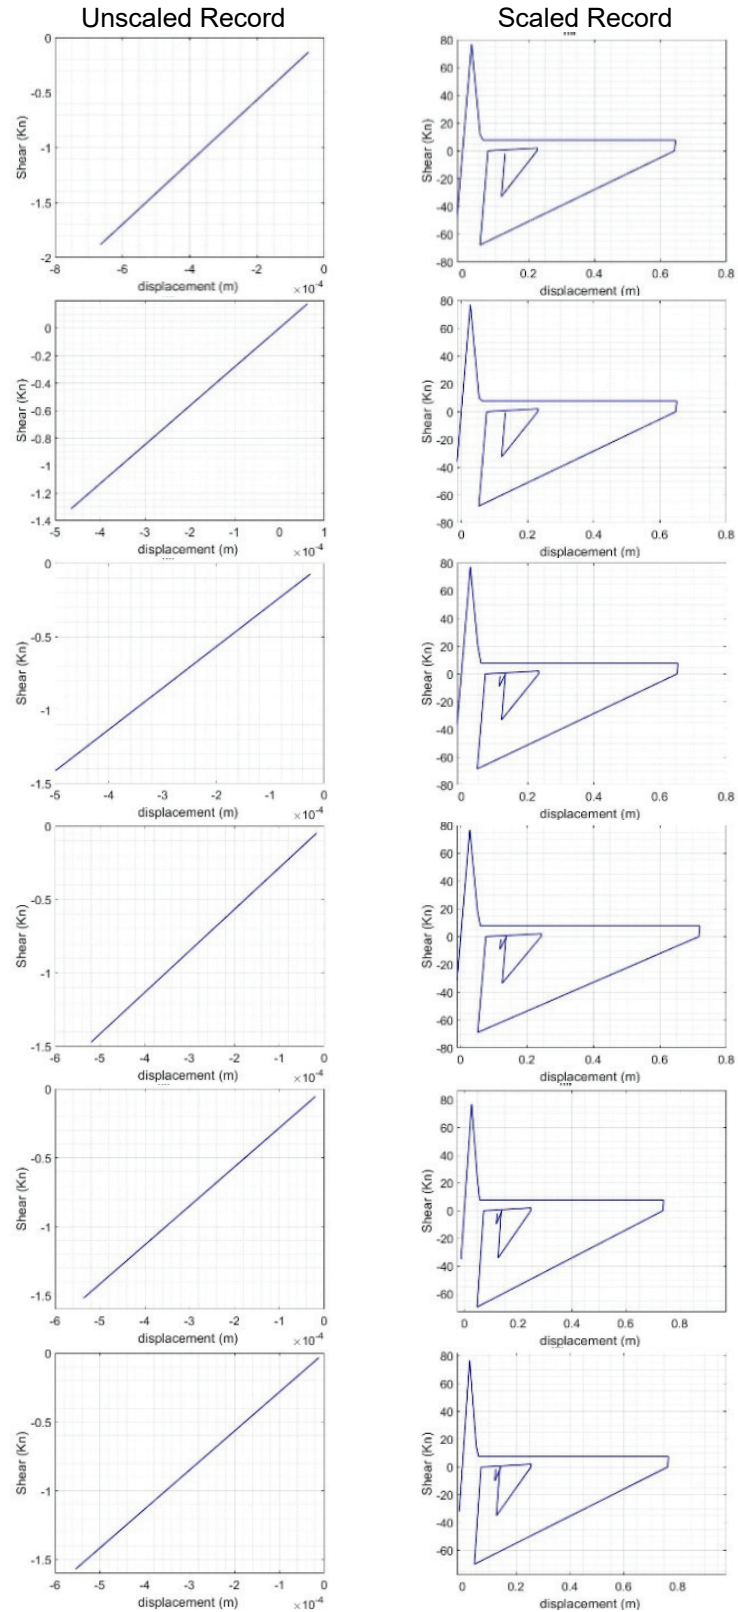
Figure 10-56　　Comparison of observed damage (left) and hysteretic response (right) for masonry elements in building façade for unscaled and scaled ground motion. Each row on the right represents one story of the building starting from the ground floor at the bottom.

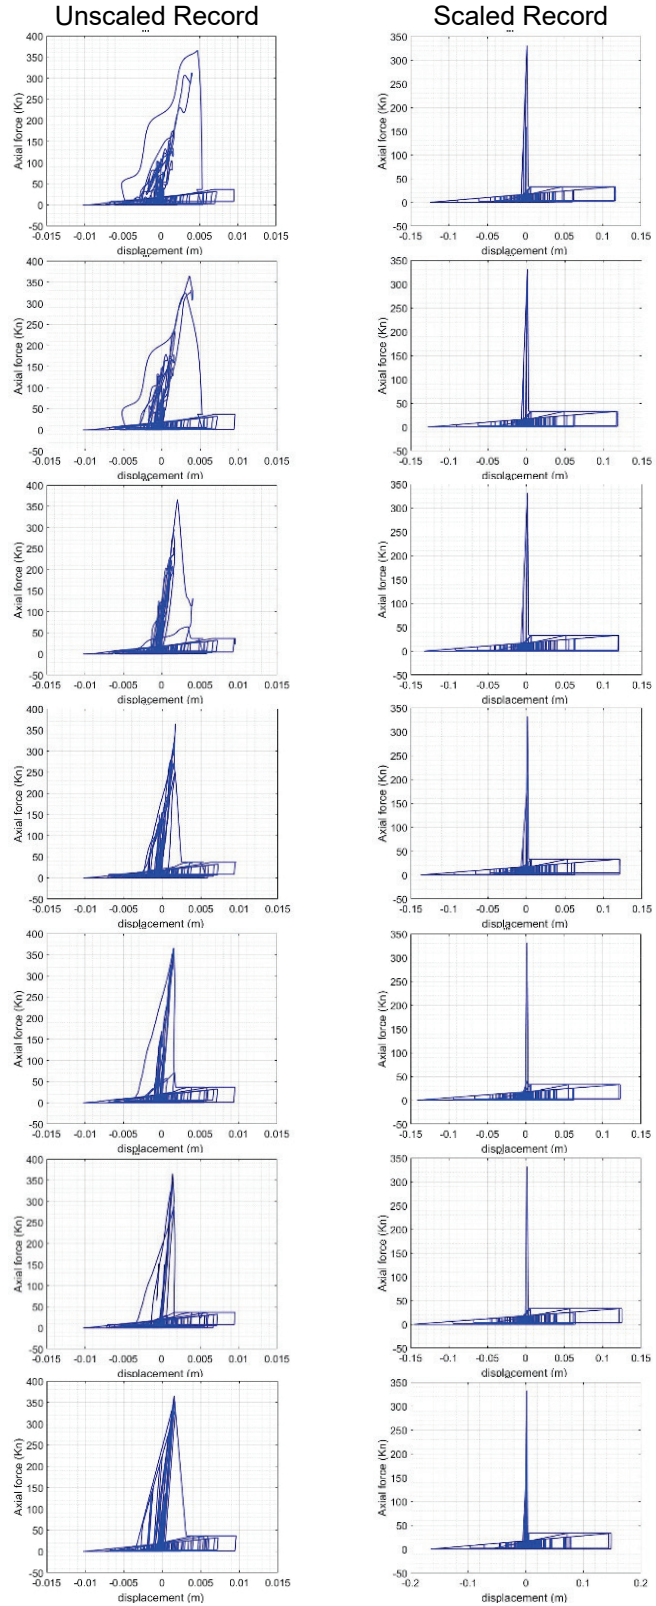
Figure 10-57   Comparison of observed damage (left) and hysteretic response (right) for masonry infills in the frame direction for unscaled and scaled ground motion. Each row on the right represents one story of the building starting from the ground floor at the bottom.
